# Thorough Inspections, Inc.

## Sample Report

1234 1st St, City/State/Zip

**Property  
Inspection  
Report**

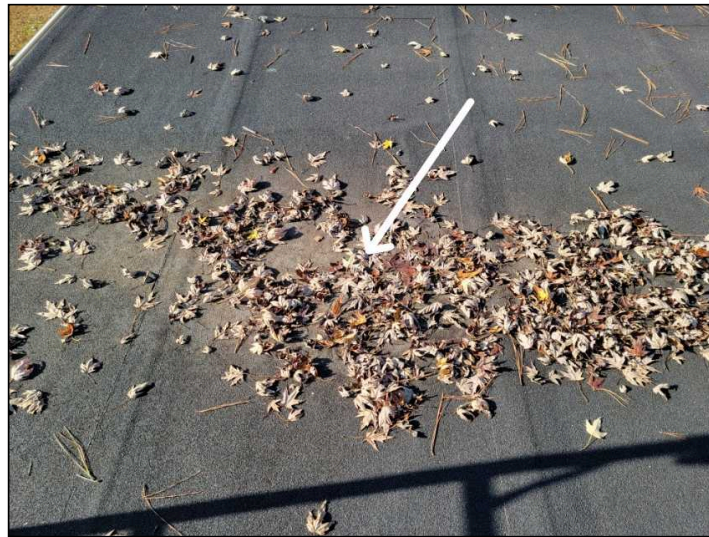
- Soft spot noted on roof/decking. Could not view from the attic or determine the cause. Recommend further review by a qualified roofing contractor, repair as needed.

Low/Settled Spot

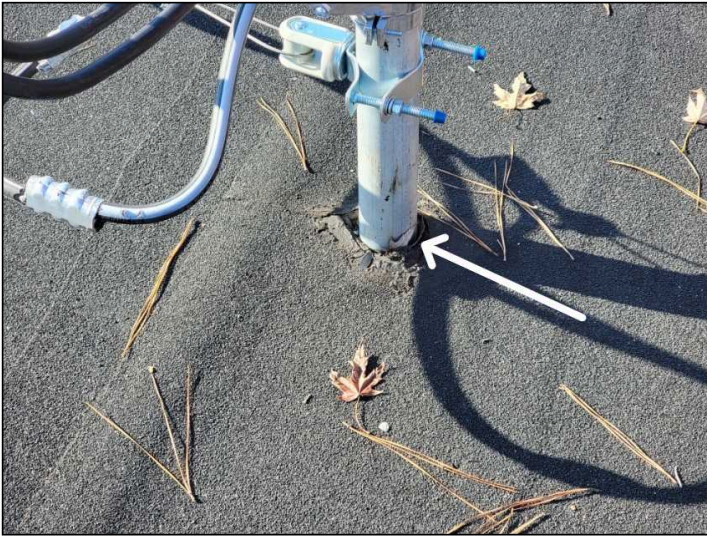
- Deteriorated/Damaged vent boot observed. Recommend repair/replace by a qualified contractor.
- **No vent boot installed. Recommend a qualified individual installing the proper boot to prevent water intrusion and wood damage.**

No Boot Installed

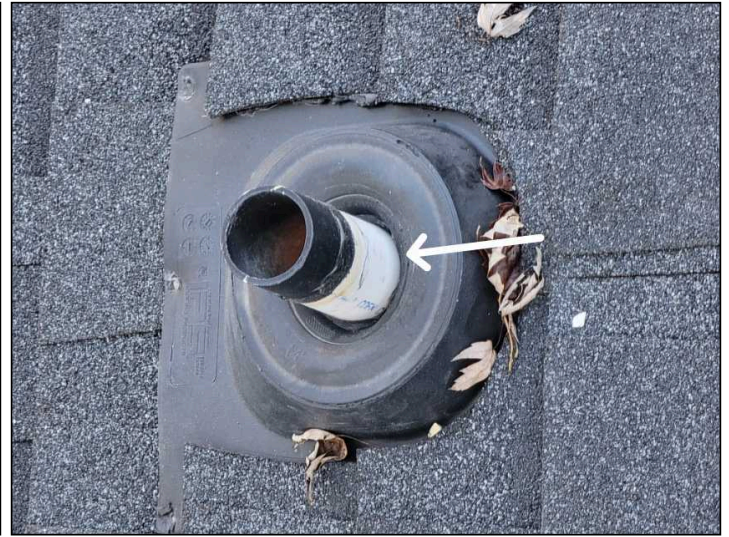
Damaged Boot

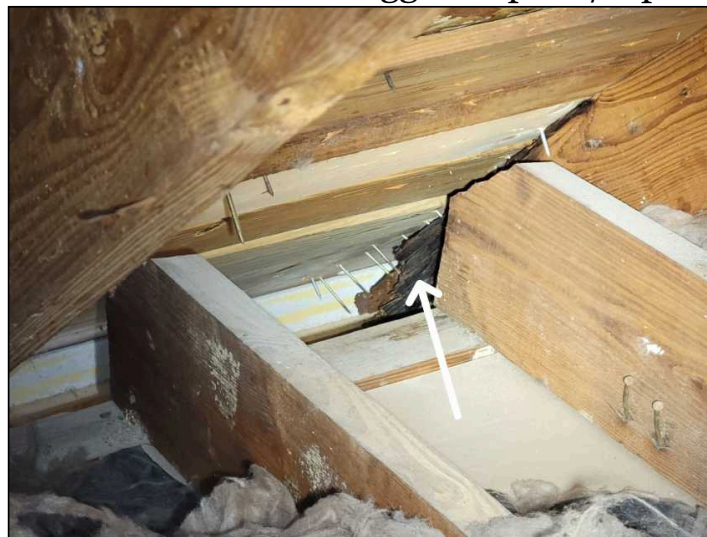
- Wood damage/deterioration observed. Suggest repairs/replacement as needed.

Damaged/Deteriorated Wood (Front Left)

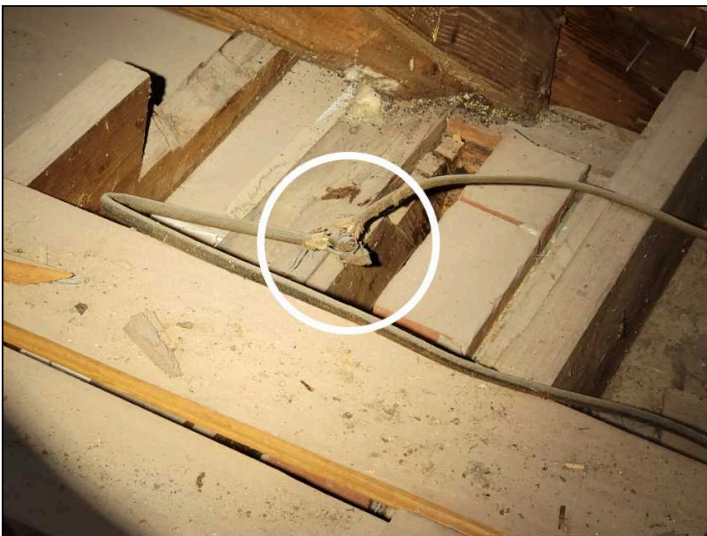
- Loose or improperly installed receptacles were found, they should be installed correctly by a licensed electrician or a qualified contractor.
- **Connections made outside of a Junction Box, which is a potential shock or electrocution hazard. Recommend a qualified individual evaluate and address as needed.**

Connections Made Outside of a Junction  
Box

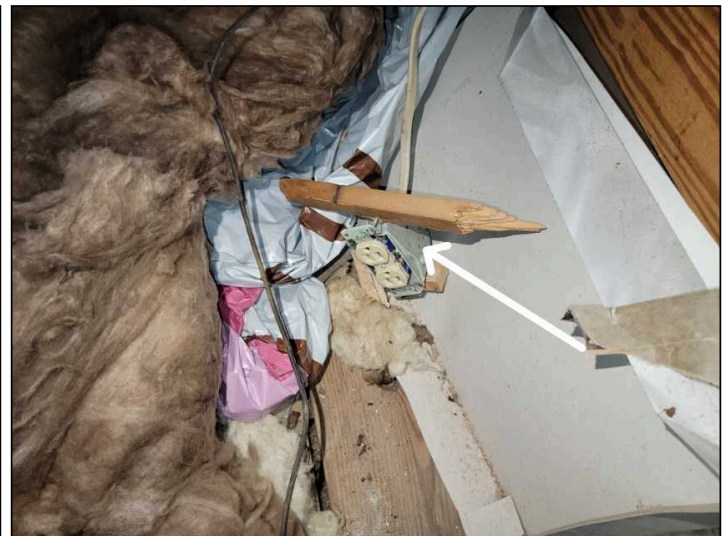
Loose Receptacle

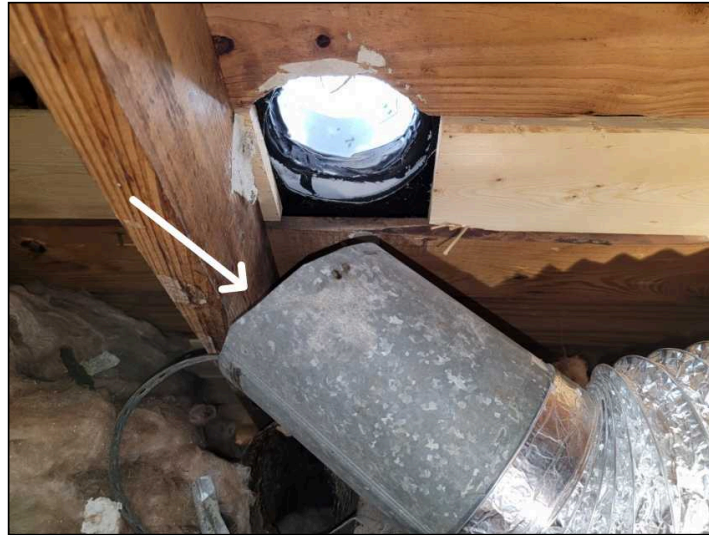
- Vent terminates in the attic. Have vent pipe connected so it is routed to the exterior of the home.

Vent Pipe Not Attached

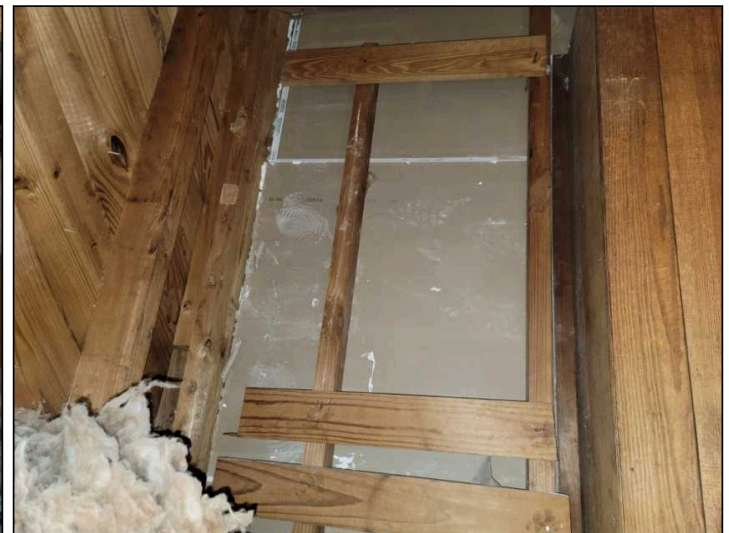
- Insulation is missing and sparse in some areas. Recommend adding or evenly spreading insulation for better energy efficiency.
- **IMPROVE:** The house has only a minimal amount of visible insulation. Expect high heating and cooling energy costs. Recommend having the home professionally insulated to reduce energy expenses.

Sparse/Missing Insulation

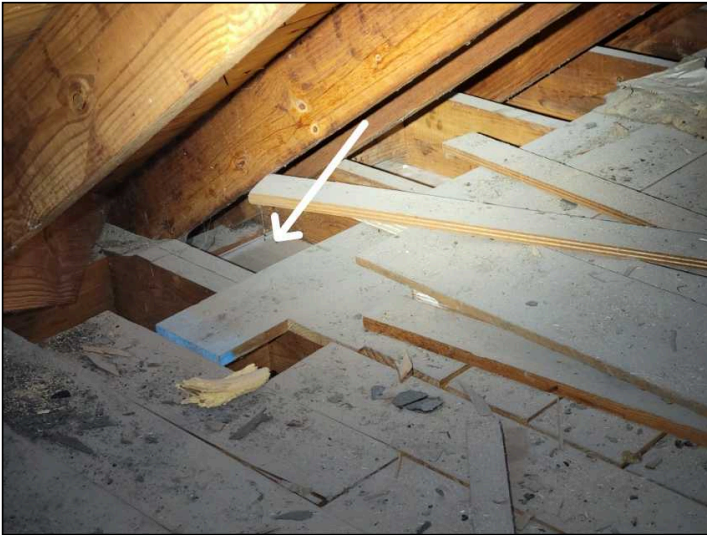
No Insulation over Main Level Front Bedroom

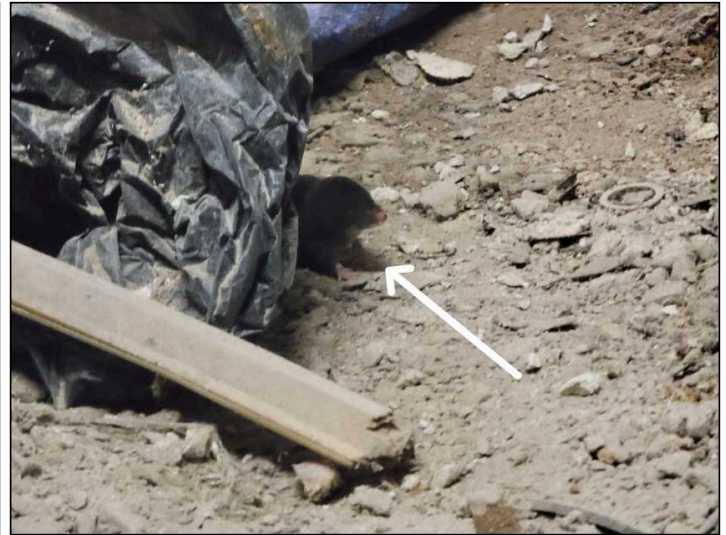
- Vermin activity observed. Vermin can damage insulation & electrical wiring. Recommend a professional pest contractor evaluate for treatment.

Vermin Activity Observed (Moe)

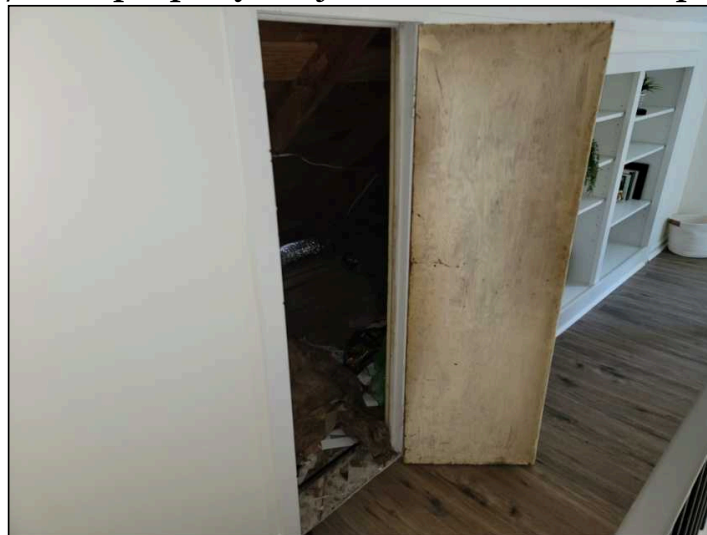
- No weather stripping around the jam of the access door. Recommend adding for better energy efficiency.
- Door does not close/latch properly. Adjustments needed for proper functionality.

Does Not Close Completely/ Properly & No Weatherstripping

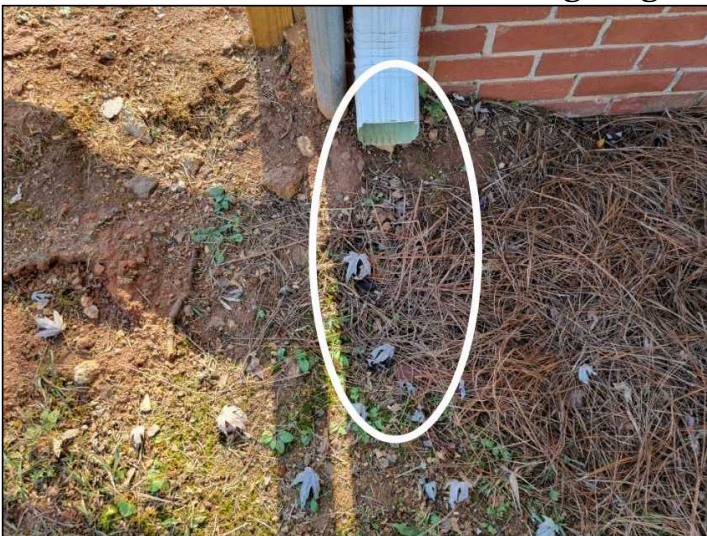
Missing Splash Blocks

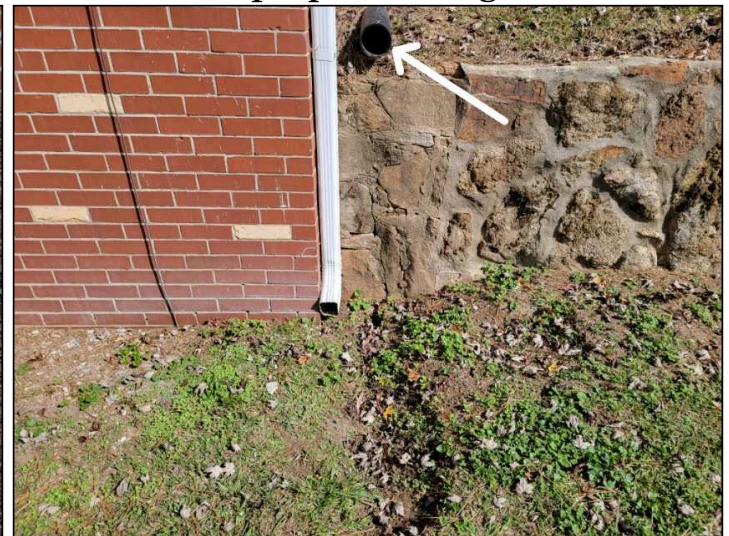
Open Drain Pipes

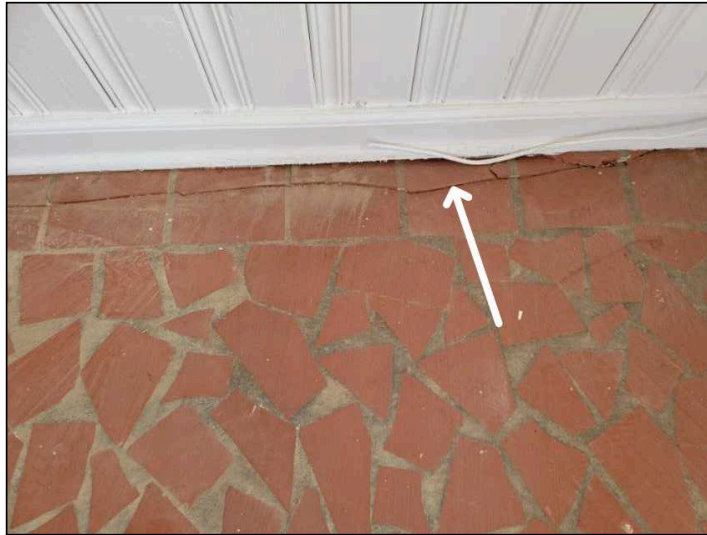
- Settlement cracking noted. This cracking is common and usually no cause for concern. Recommend monitoring for widening or spreading. Contact a qualified contractor should condition worsen or if water intrusion occur.

Settlement Crack Noted

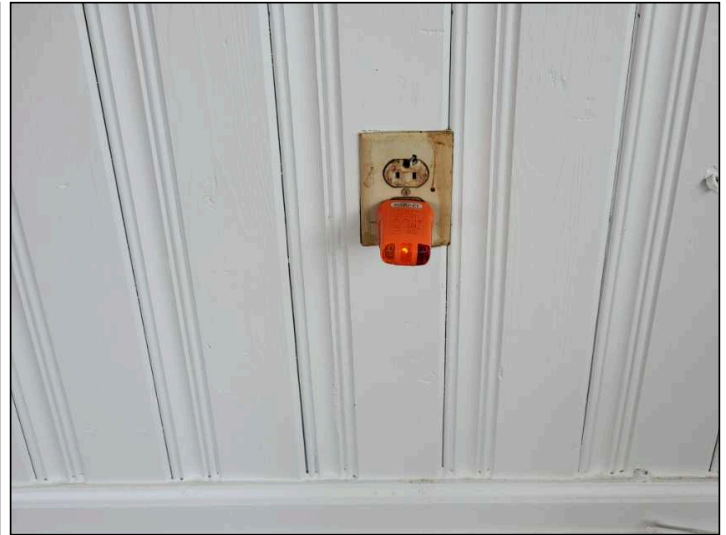
Open Ground (Screened-In Porch)

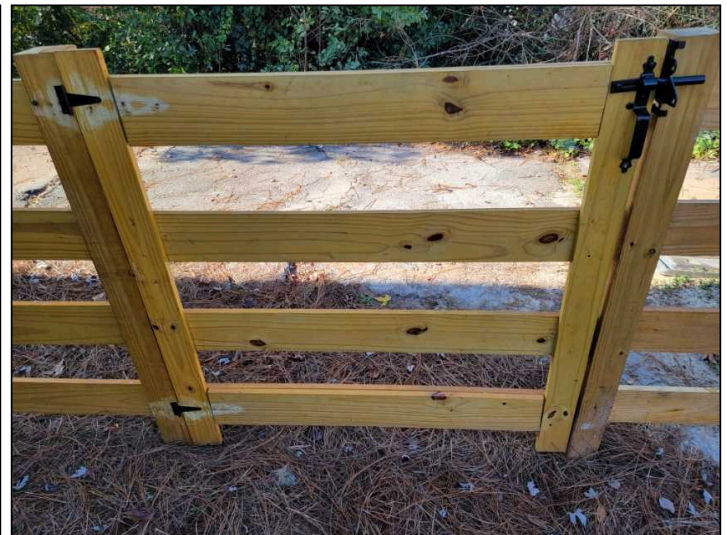
Gate Sags

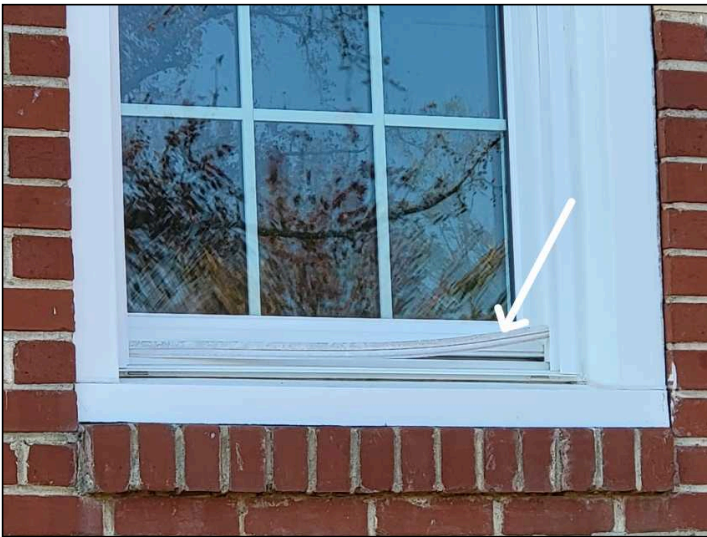
- Damaged, loose or missing hardware observed. Recommend repair/ replacing these components for proper functionality.

Damaged/Loose Hardware (Right Side)

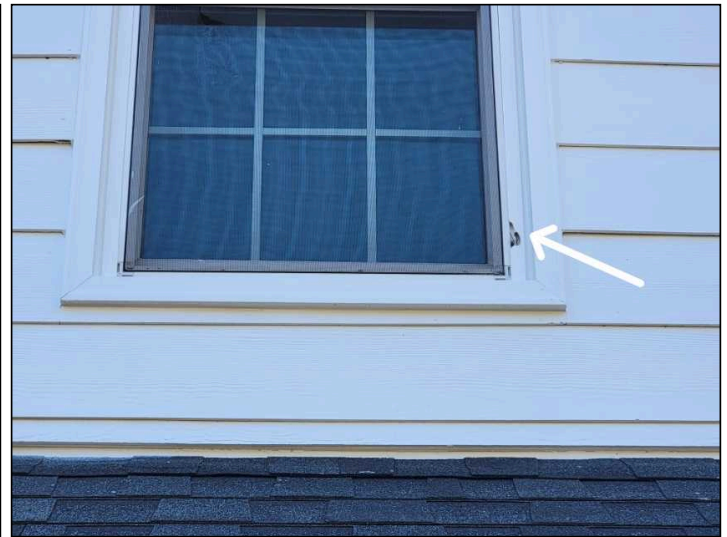
Damaged Frame (Rear)

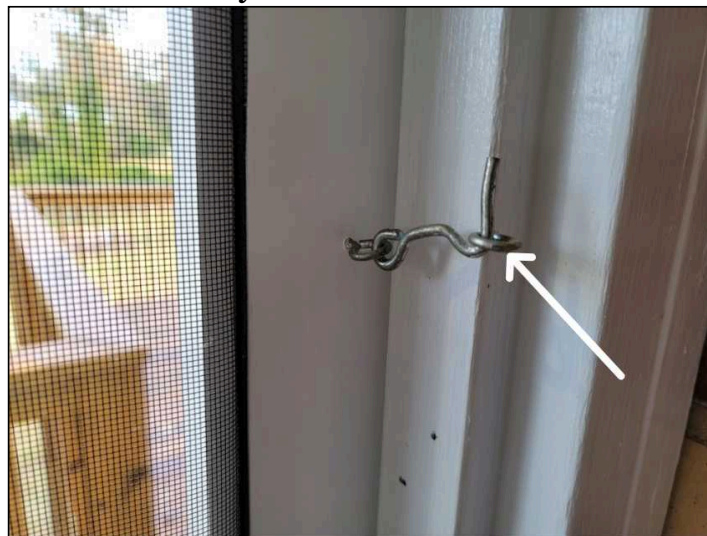
Latch/Lock Installed Upside Down

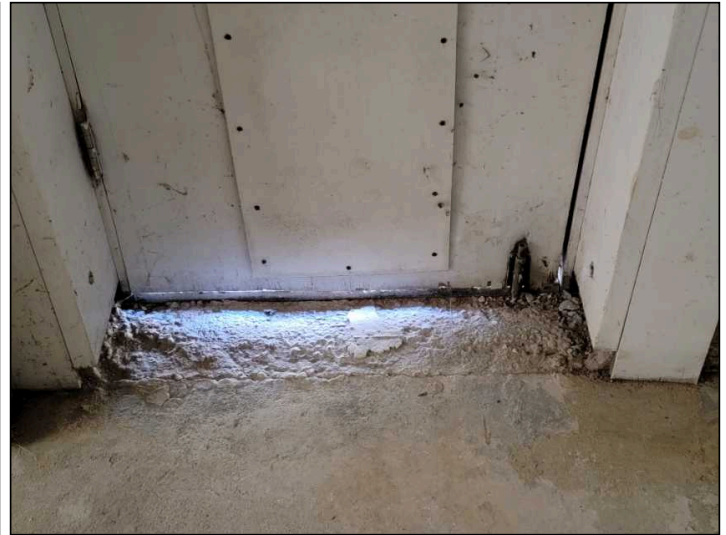
Daylight Visible Under Door (Basement)

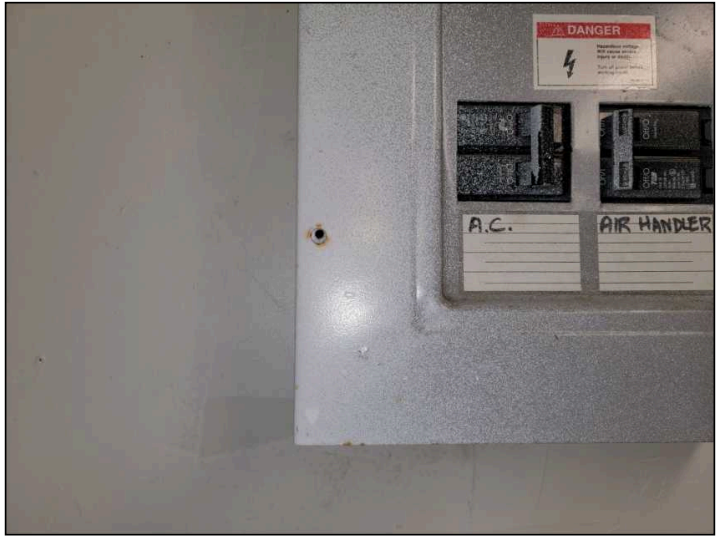
Panel Cover Screw Missing (2nd Sub Panel)

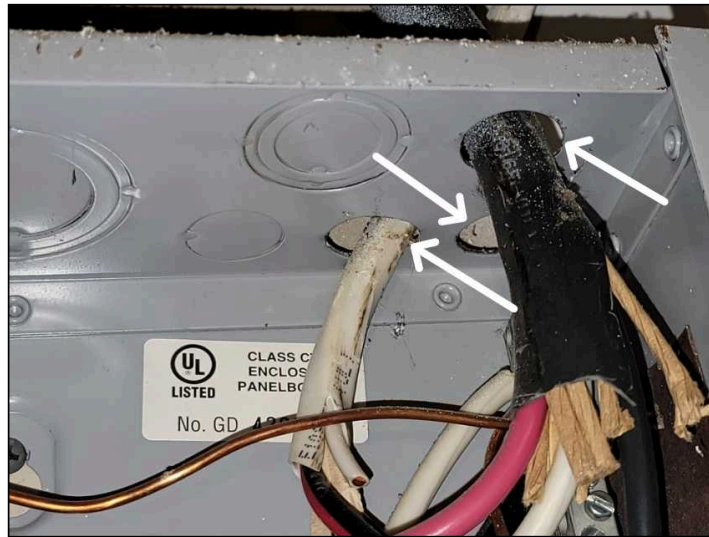
Missing Knock-Out Caps & Bushings (2nd Sub Panel)

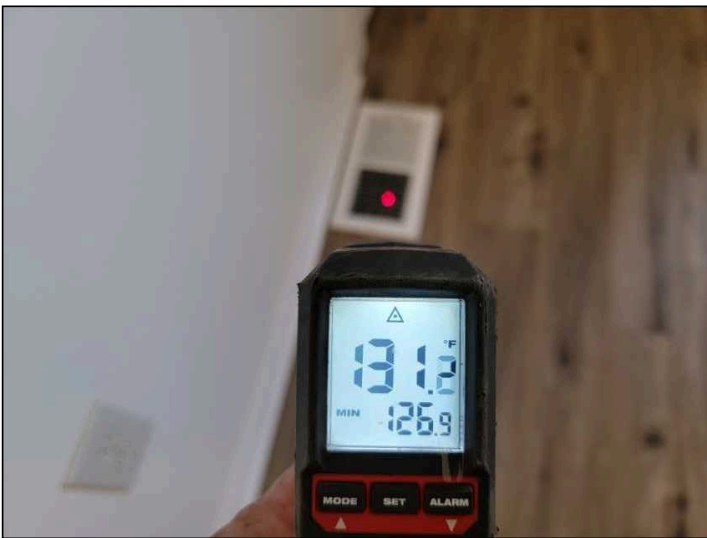
Heat Tested (131°F)

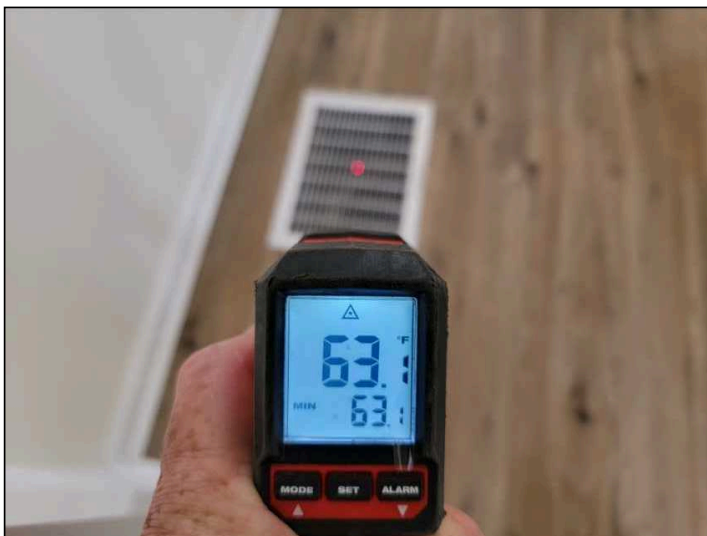
Return/Air in temperature (63°F)

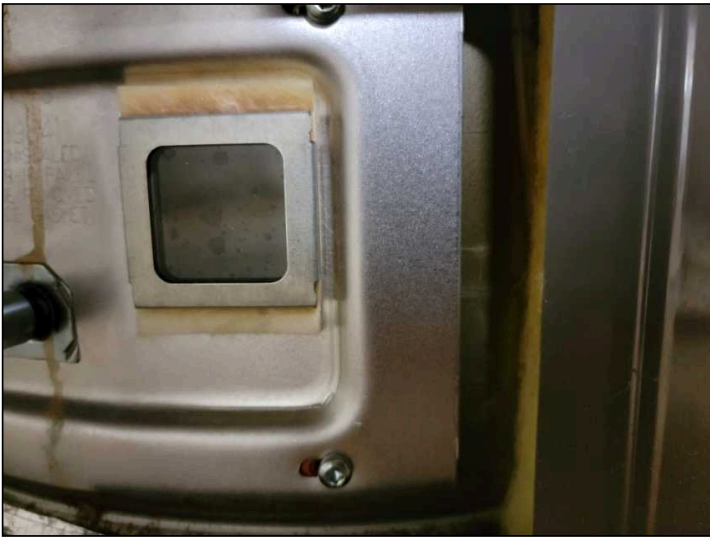
- Rheem
- The water heater was manufactured by Rheem in 2021, and has a capacity of 50 gallons.
- **Water heater would not light/stay lit. This could be caused by a bad thermo coupling. Could not test fixtures for hot water at the time of inspection. Recommend repairs by a qualified contractor or individual.**

No Pilot Light (Would Not Stay Lit)

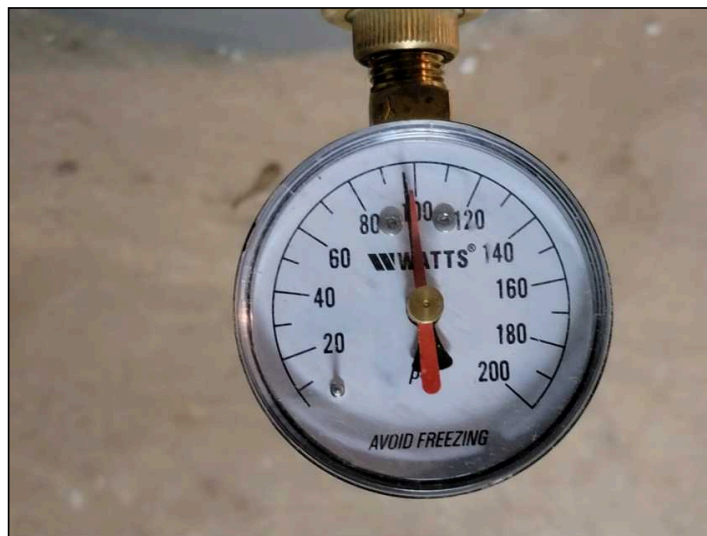
- **Water pressure noted at approximately 98 PSI. This is too high (Recommended water pressure is 40-80 PSI.) Recommend adjusting for proper pressure.**

Water Pressure Tested at Approximately (98 PSI)

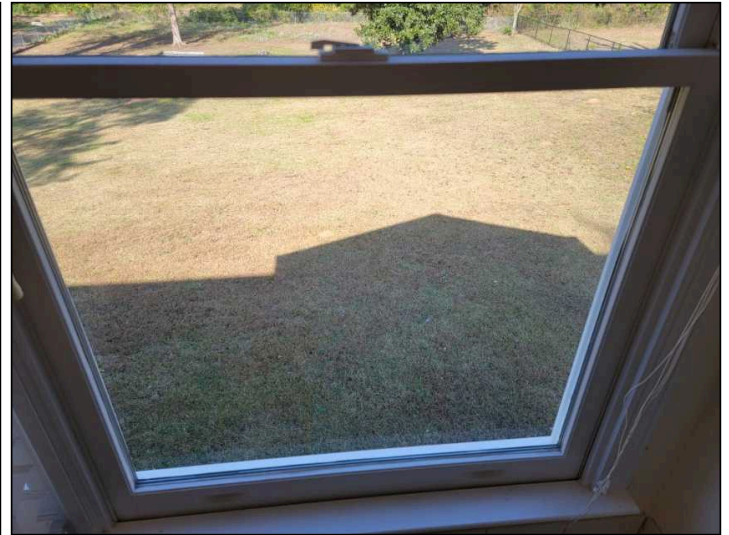
Does Not Open (Master Bathroom)

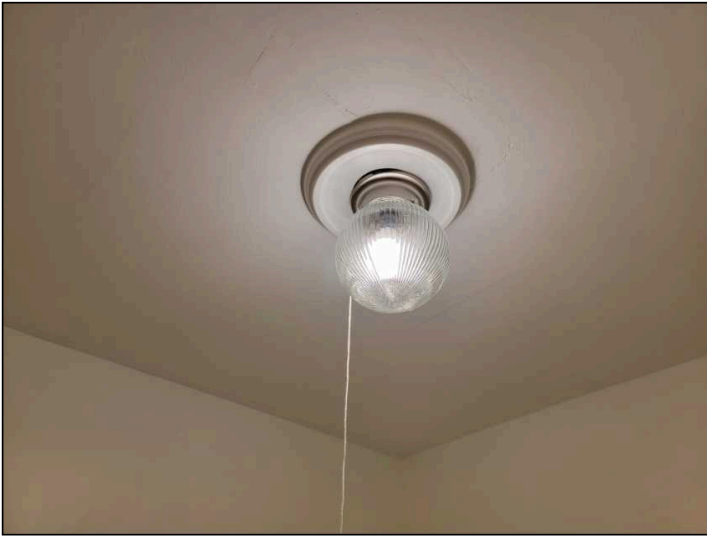
Loose Fixture (Left Bedroom Closet)

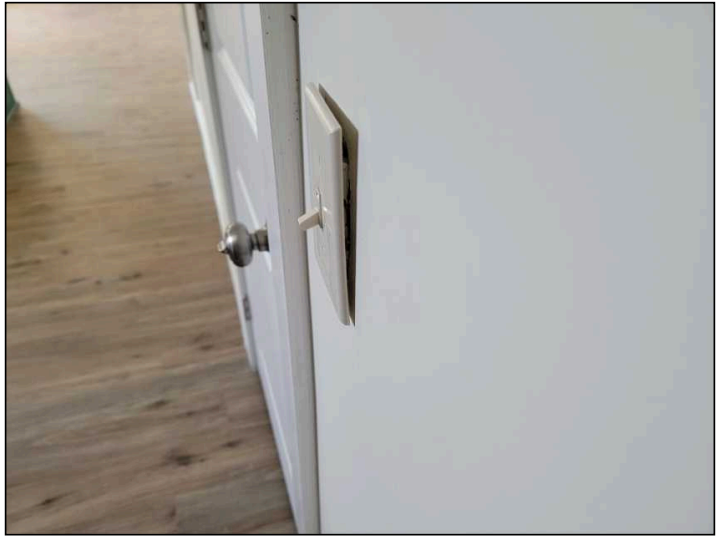
Loose Switch Box (Basement Stairway Light)

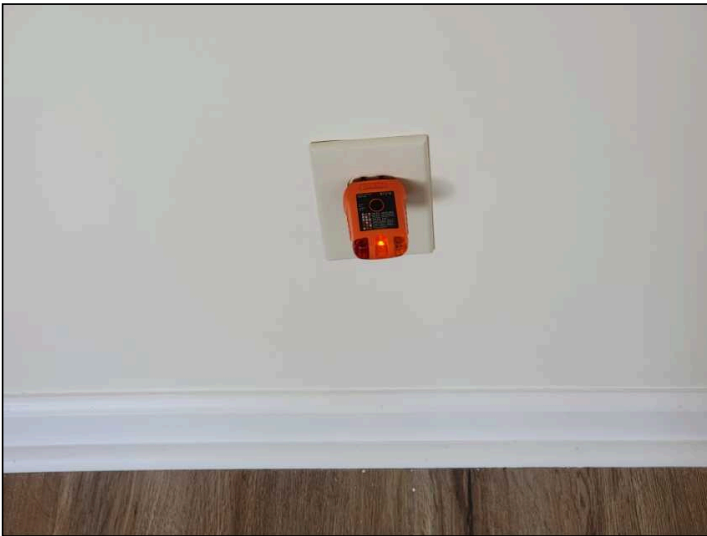
Loose Receptacle & Open Ground (Family Room, Front Wall)

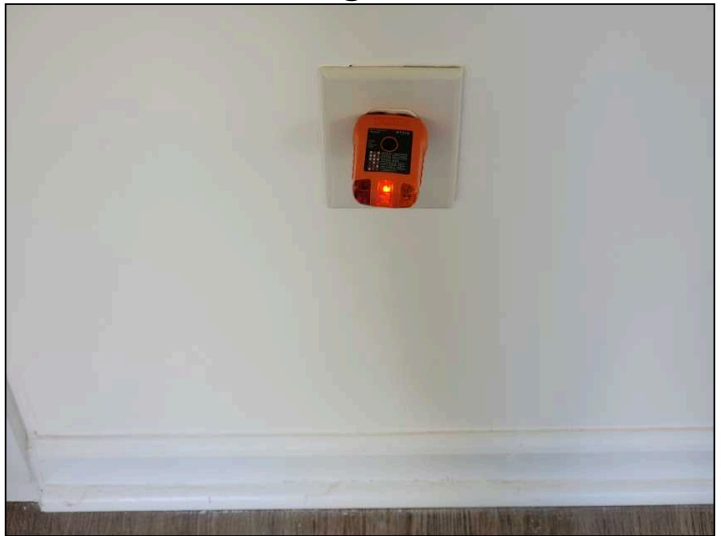
Loose Receptacle & Open Ground (Upstairs Left Bedroom) ALL Receptacles

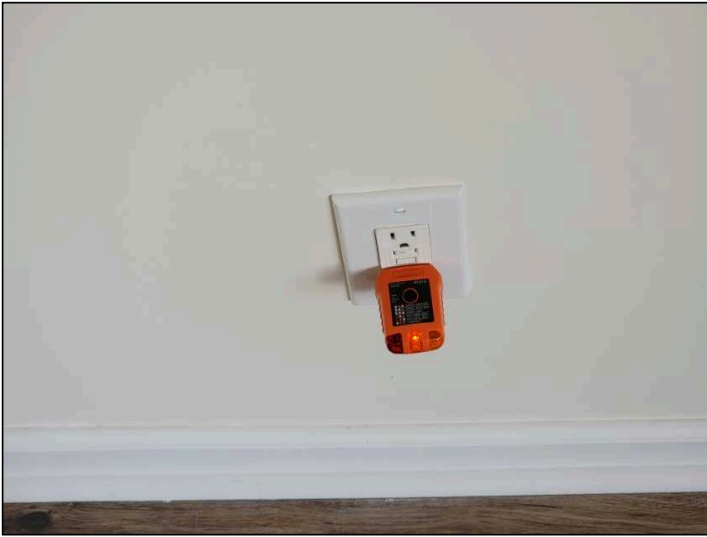
Open Ground (Family Room)

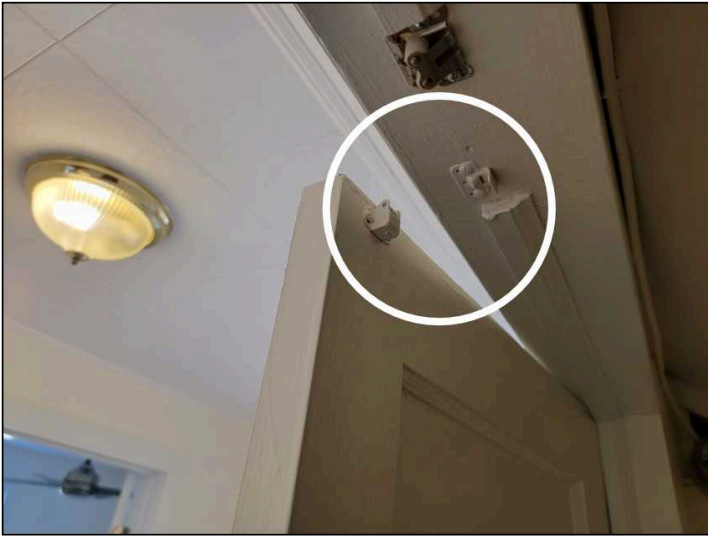
Missing/Damaged Hardware (Upstairs Hall Closet)

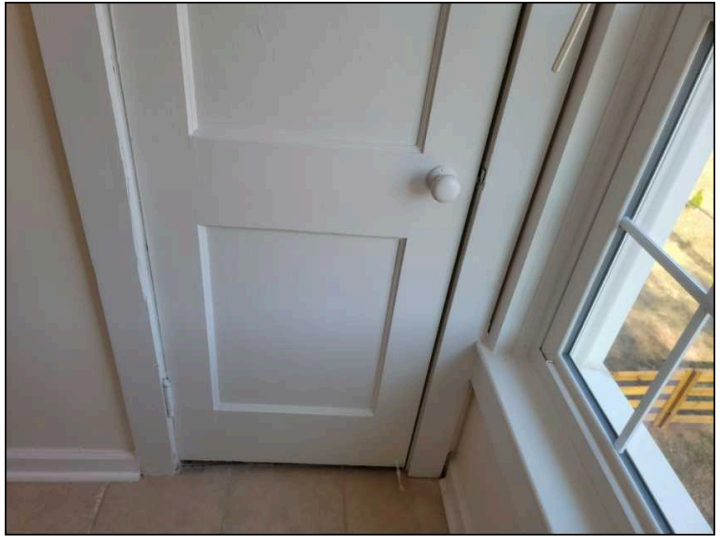
Does Not Close/Latch (Guest Bathroom Closet)

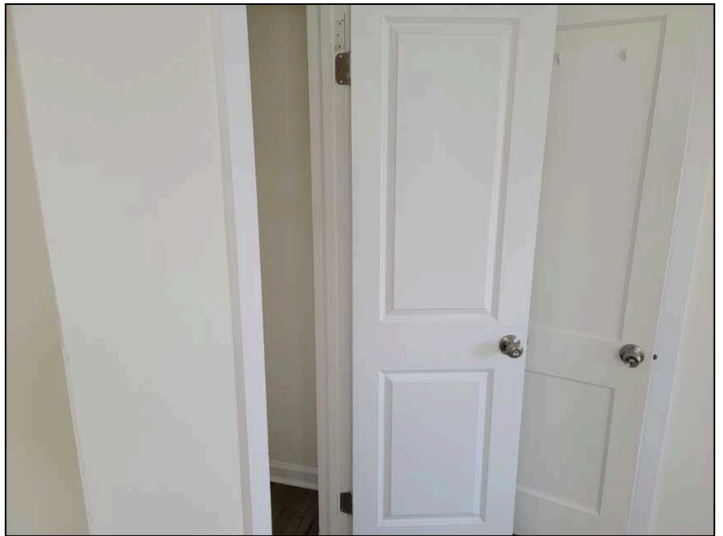
Missing Screws/Hardware (Main Level Front Bedroom Closet)

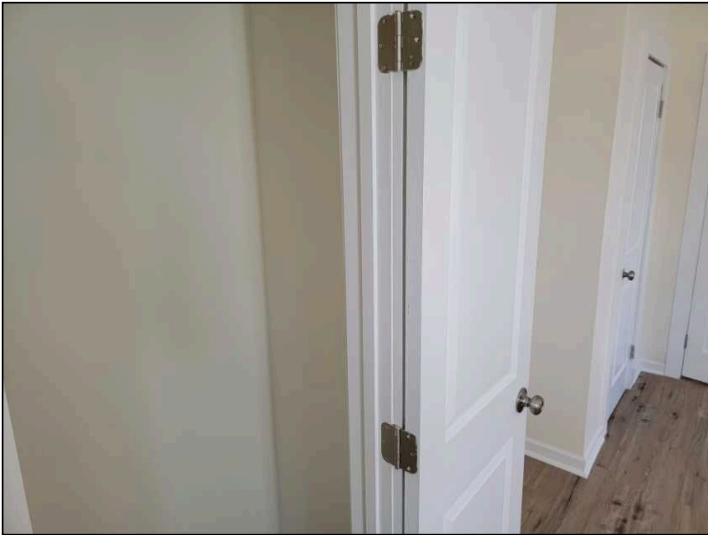
Missing Screws/Hardware (Main Level Front Bedroom Closet)

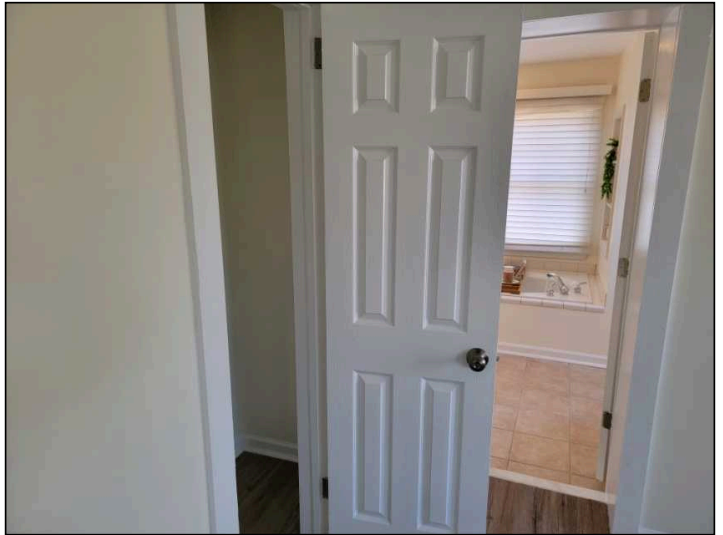
Door Rubs & Loose Hinge (Master Closet)

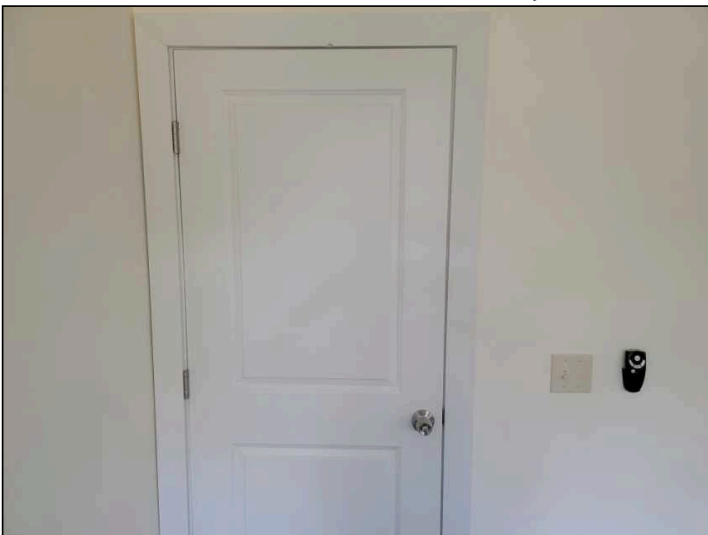
Does Not Close/Latch (Upstairs Left Bedroom)

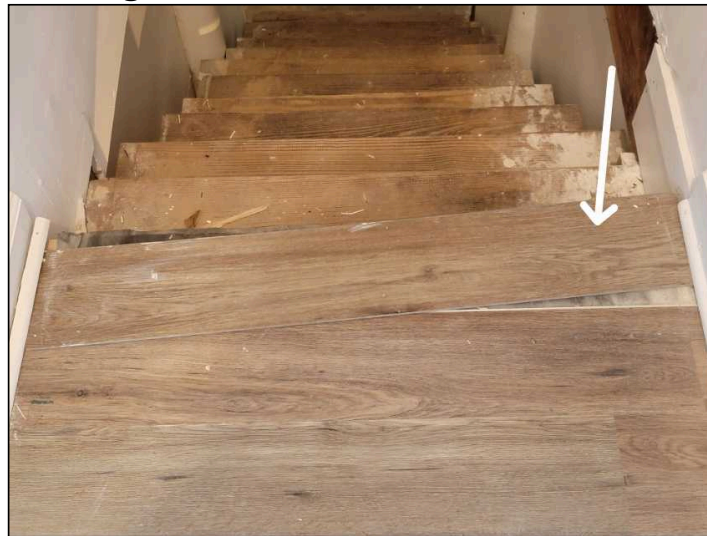
Loose Flooring (Top Of Basement Stairs)

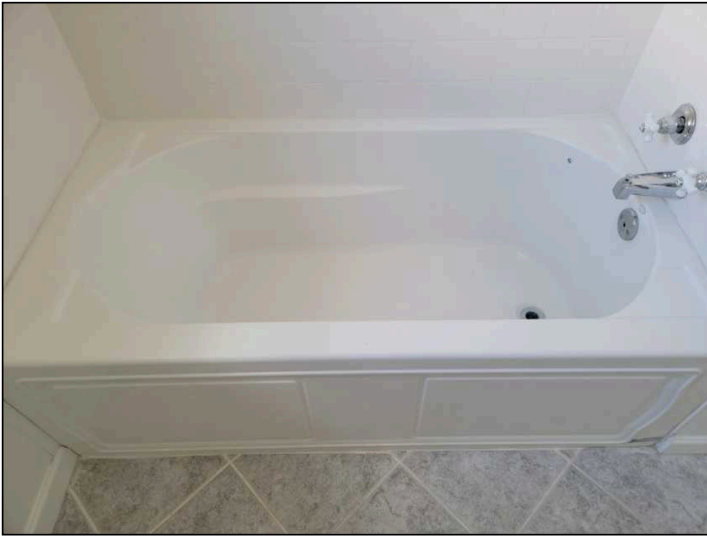
Caulk/Seal All Cracks & Gaps (Guest)

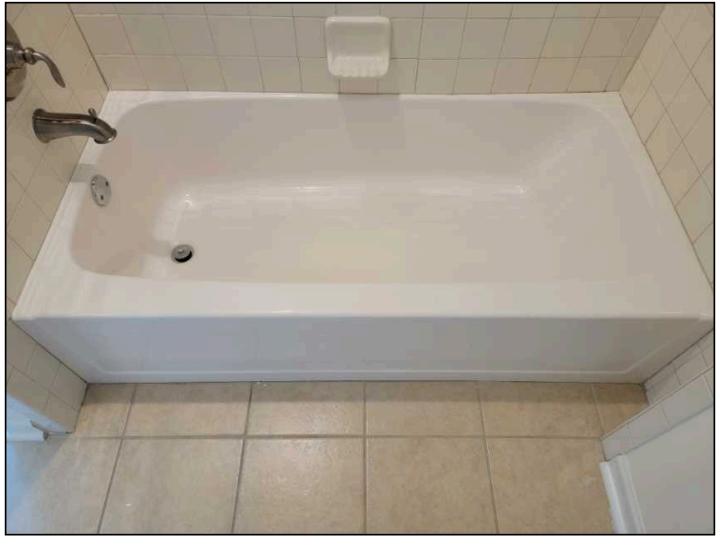
Caulk/Seal All Cracks & Gaps (Upstairs Guest)

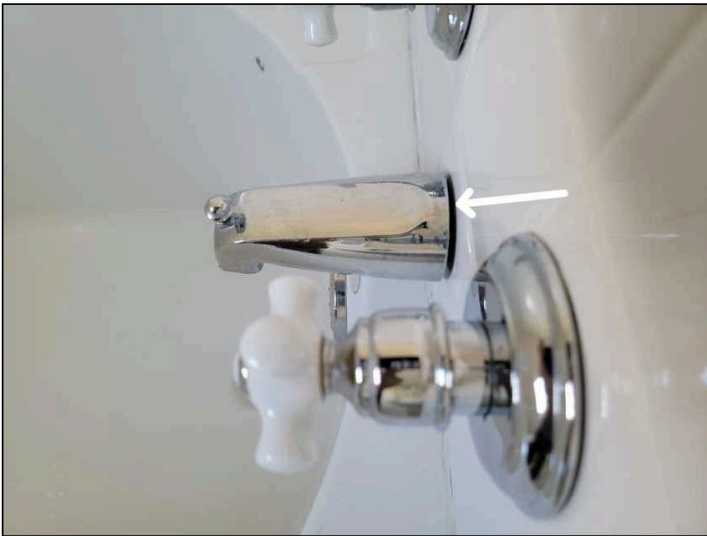
Gap Observed (Guest)

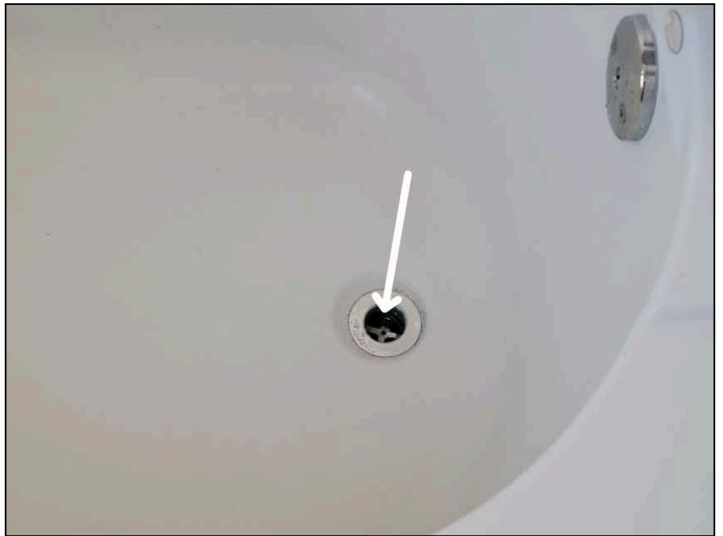
No Stopper (Guest)

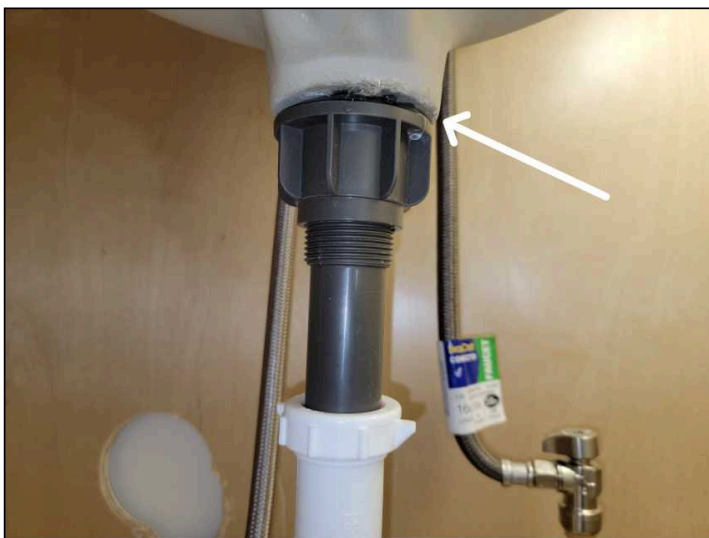
Active Leak Observed (Master)

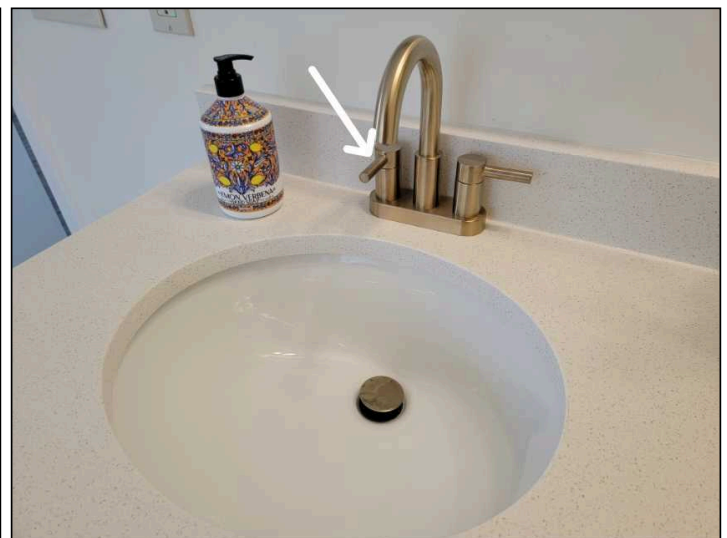
No Hot Water Supply (Master)

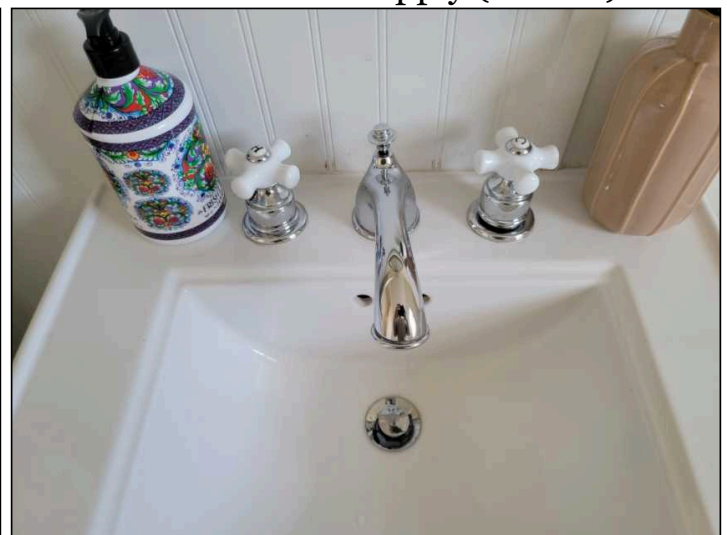
Loose Assembly (Guest)

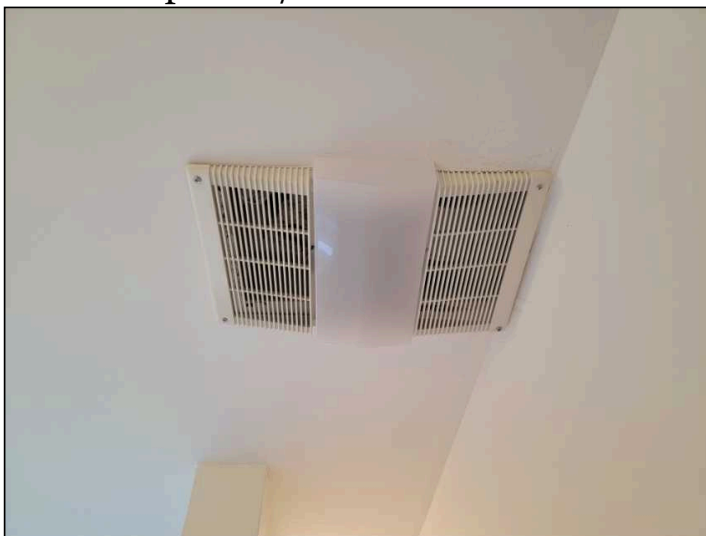
Light Inoperable (Upstairs Guest)

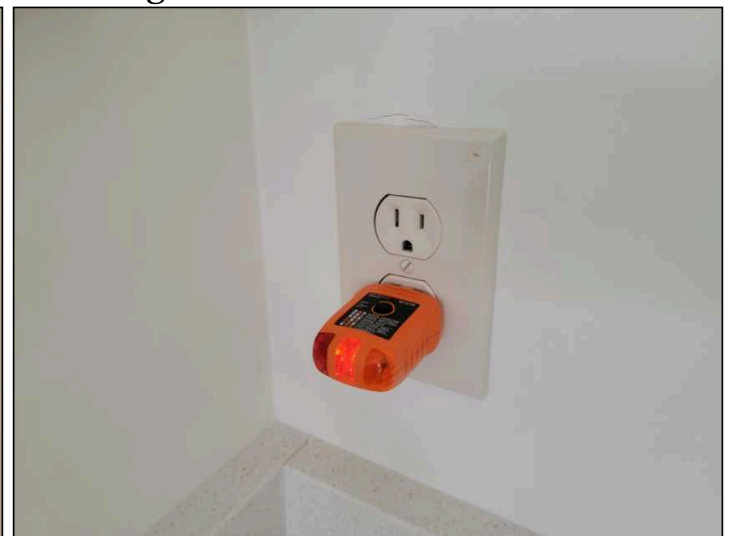
Open Ground & Loose Receptacle (Master)

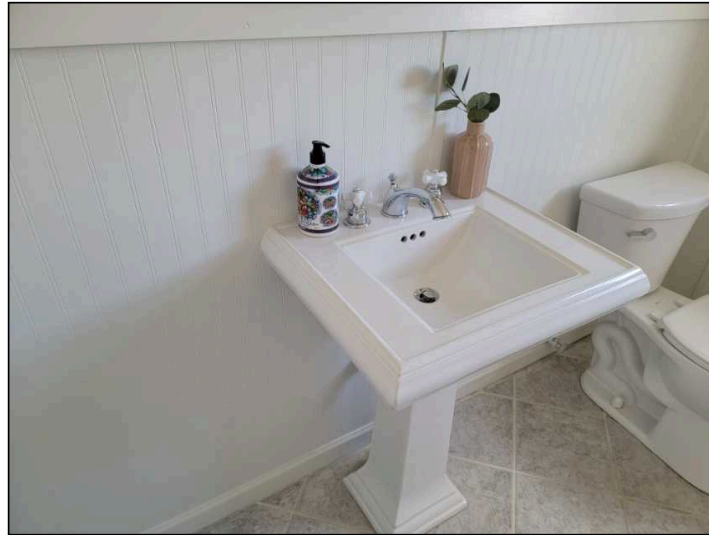
No Receptacles Observed (Guest)

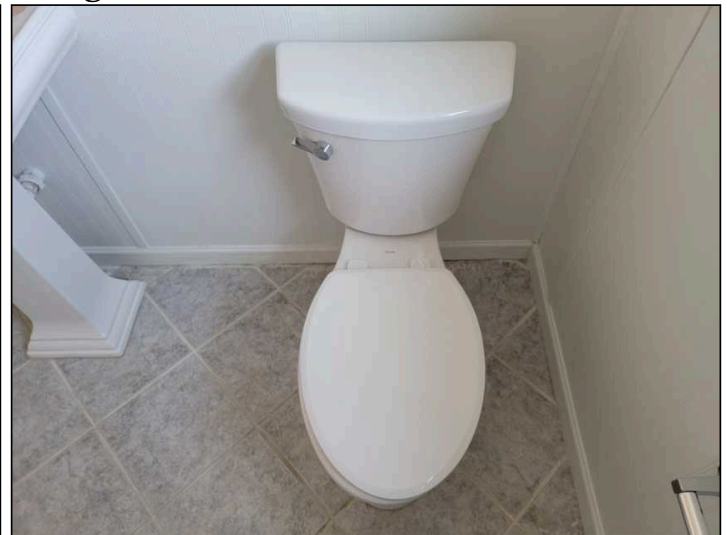
Loose Toilet (Guest)

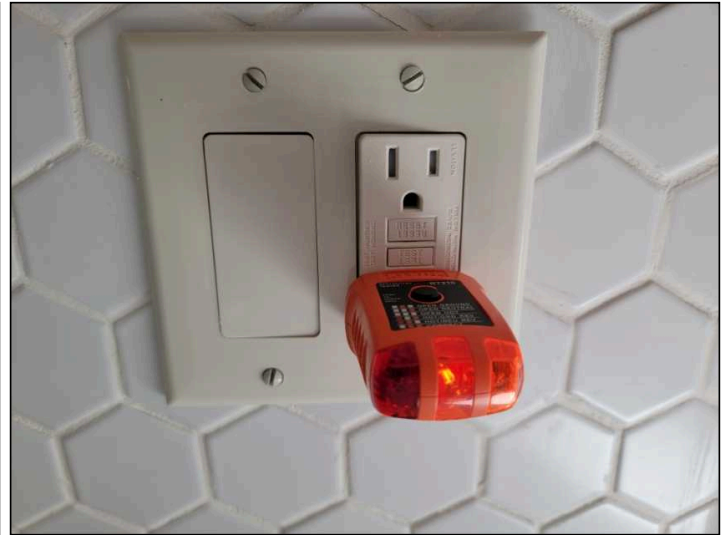
Open Ground

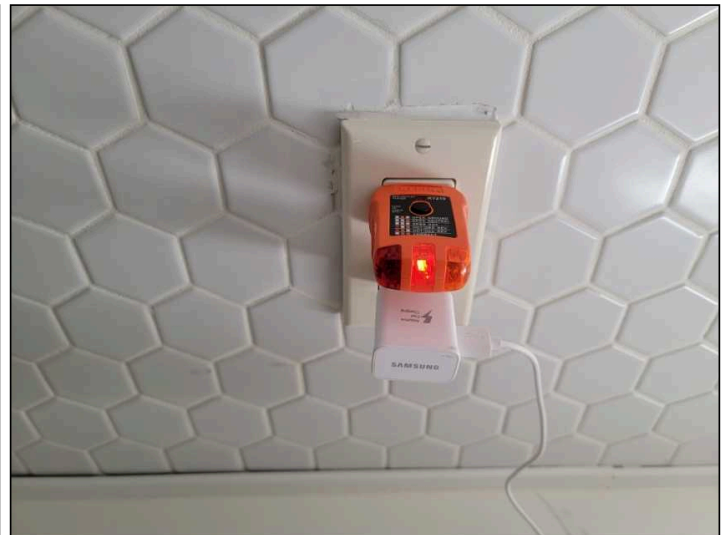
Bad **GFCI** (Open Ground)

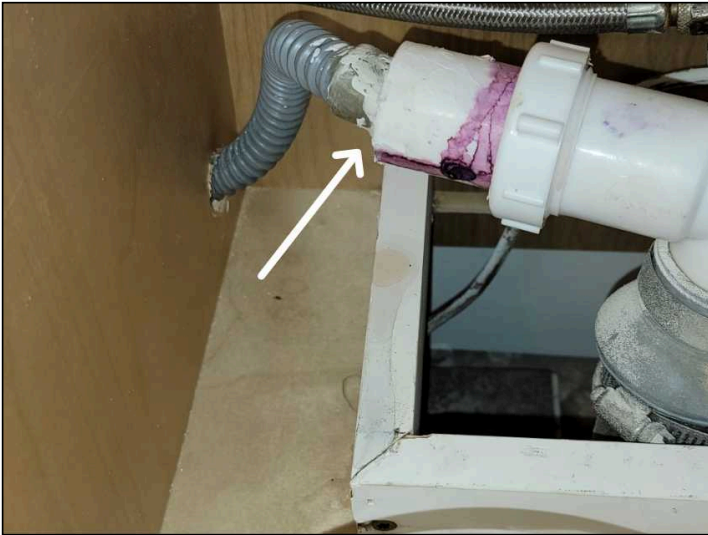
Active Leak Observed

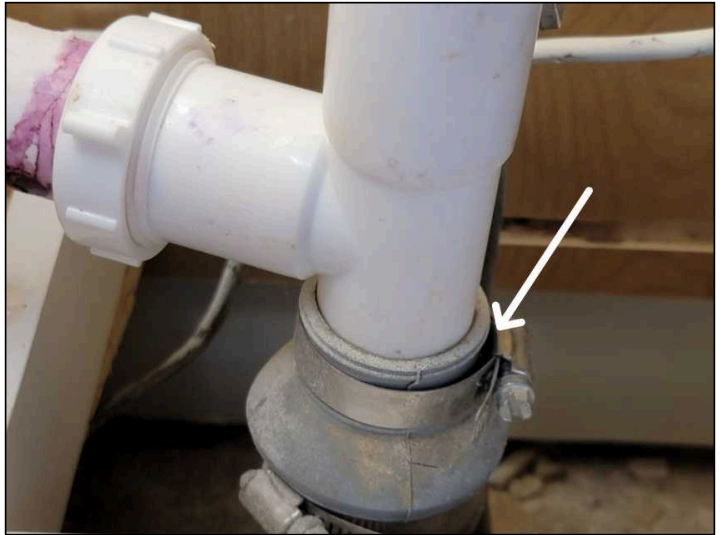
Loose Fitting

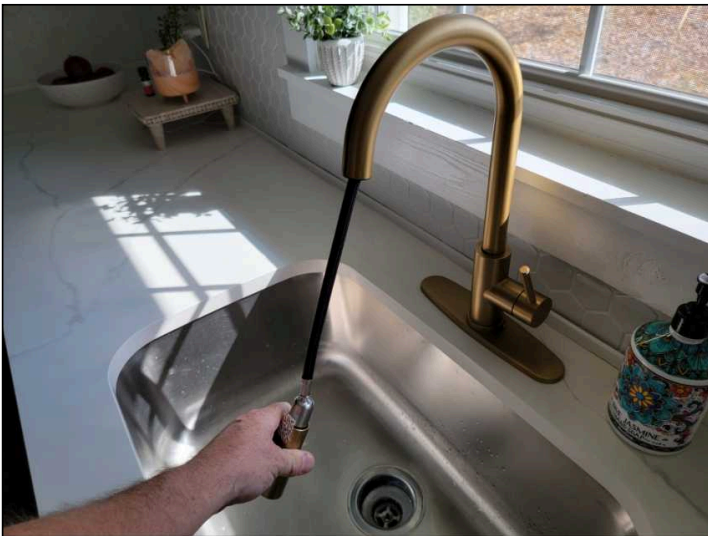
Weight Installed Too High

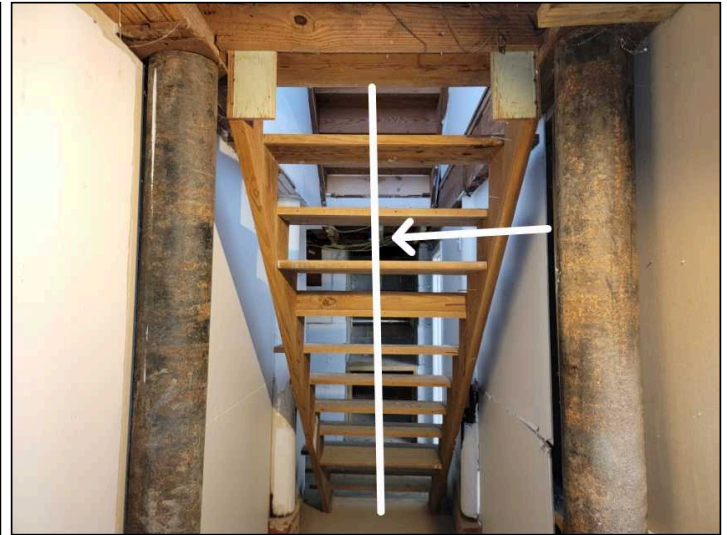
Missing 3rd Stringer

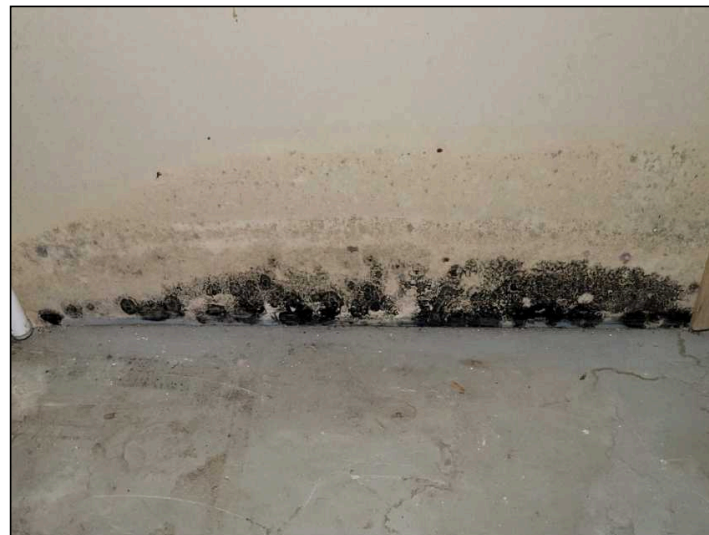
- Although there are no signs of water penetration, take caution and consider any basement as wet until experience proves it dry.
- **Mold-like bio growth observed. Professional testing & evaluation advised. Recommend a qualified contractor evaluate and address as needed.**

Bio-Growth Observed
