# Thorough Inspections, Inc.

## Sample Report

1234 1st St, City/State/Zip

**Property  
Inspection  
Report**

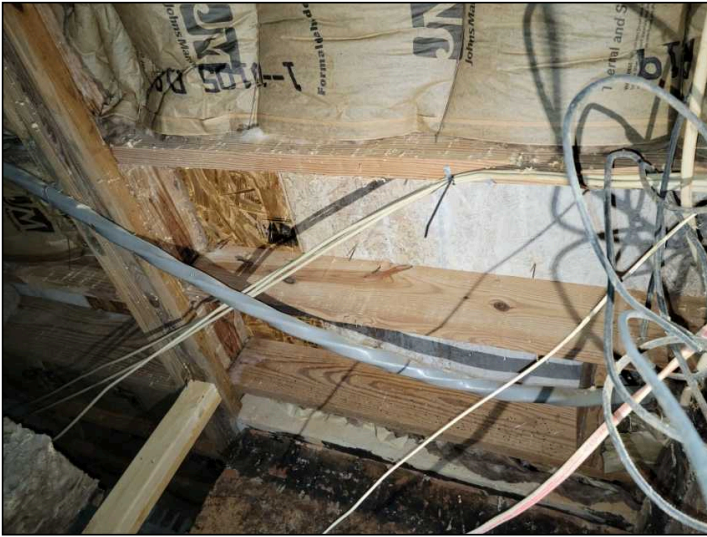
- Insulation was observed to be missing or out of place in the crawlspace. Recommend upgrading to promote proper insulation and increase the efficiency of home.

Missing Insulation

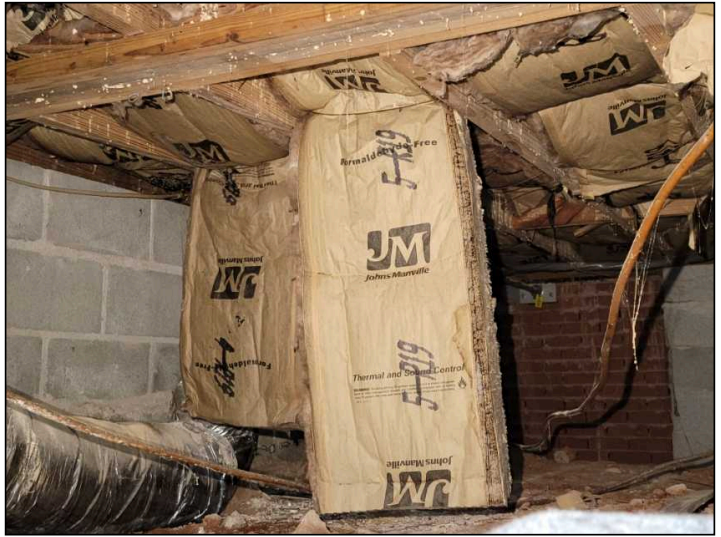
Loose Insulation

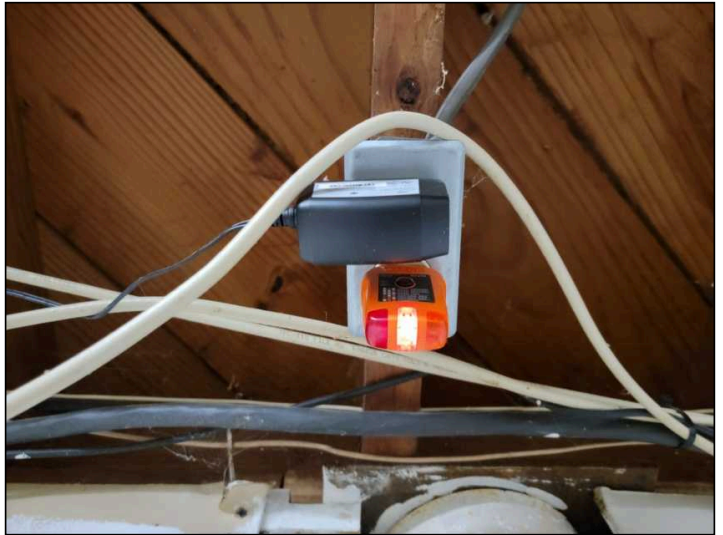
Open Ground

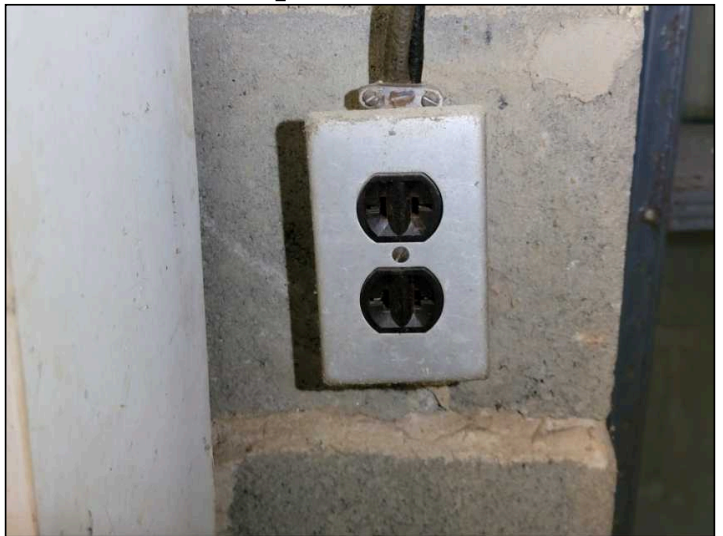
2 Prong Receptacle Noted

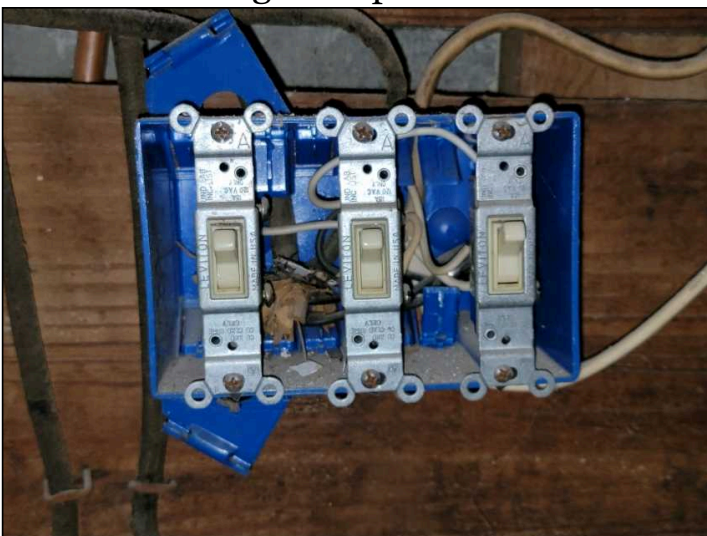
Missing Cover Plates

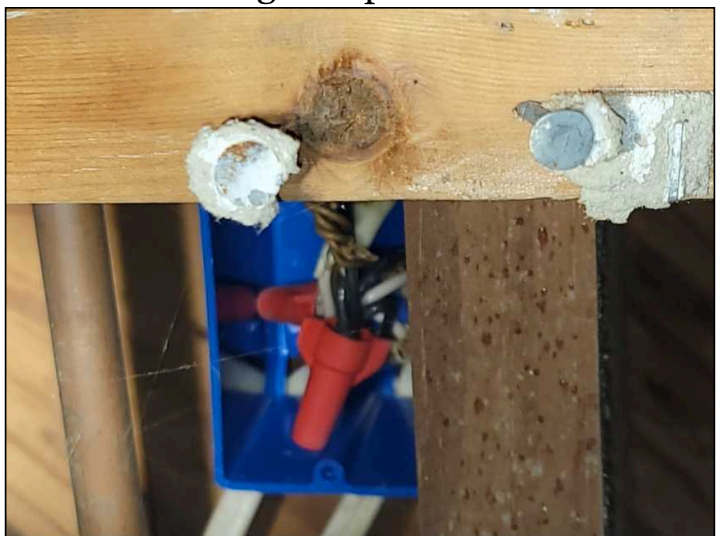
Open Junction Box

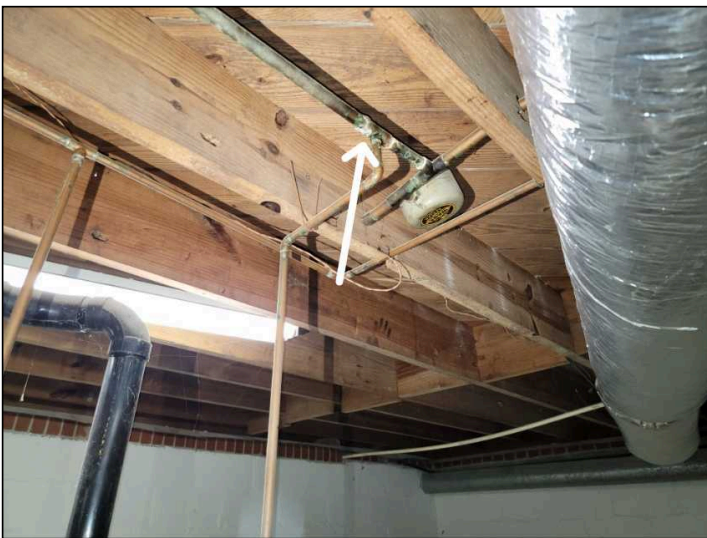
• **Active leak observed. Recommend a qualified individual to evaluate and address as needed.**

Active Leak Observed (Basement)

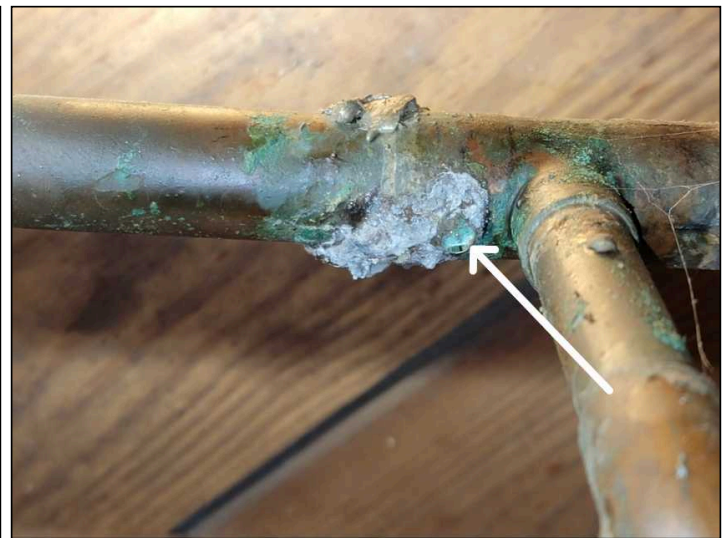
Active Leak observed (Zoomed-In)

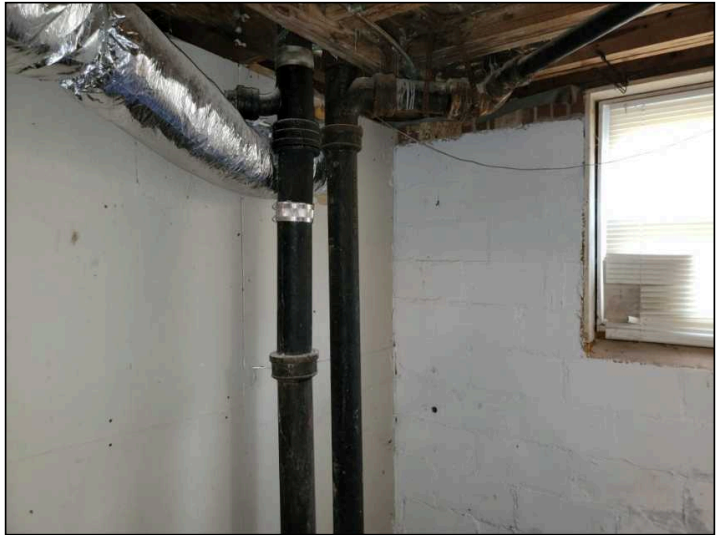
• Cast iron drain lines have a life expectancy of 30-50 years. Recommend budgeting for replacement in the near future at areas where rust cysts are visible, BEFORE leaks occur.

Cast Iron Drain Pipes

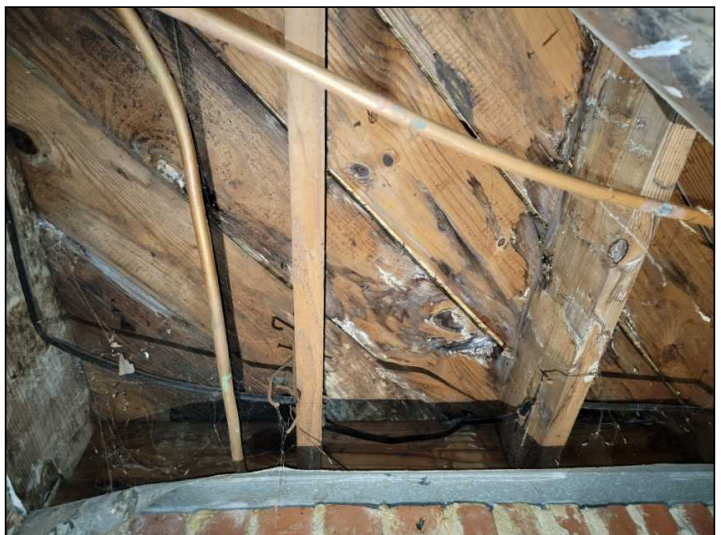
Bio-Growth Observed

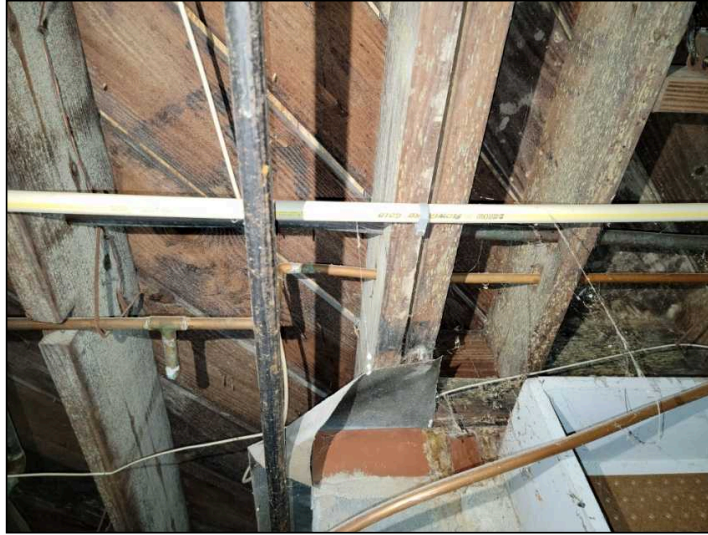
Bio-Growth Observed
