# Thorough Inspections, Inc.

## Sample Report

1234 1st St, City/State/Zip

**Property  
Inspection  
Report**

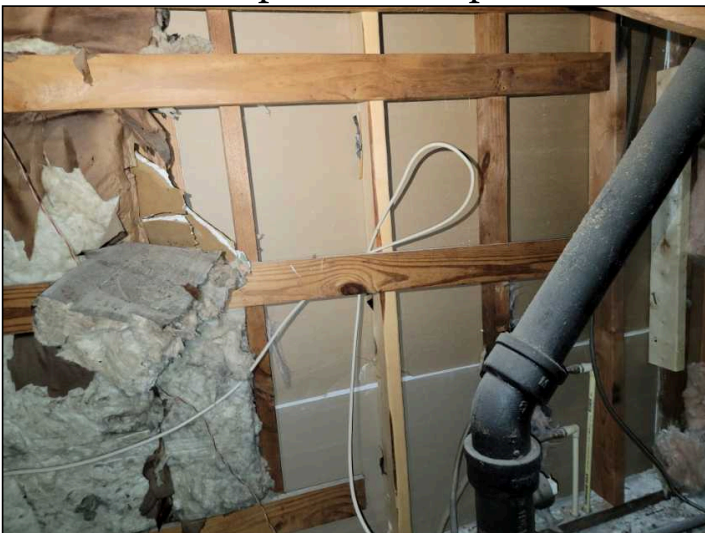
- Insulation is missing and sparse in some areas. Recommend adding or evenly spreading insulation for better energy efficiency.
- **IMPROVE:** The house has only a minimal amount of visible insulation. Expect high heating and cooling energy costs. Recommend having the home professionally insulated to reduce energy expenses.

Sparse/Missing Insulation

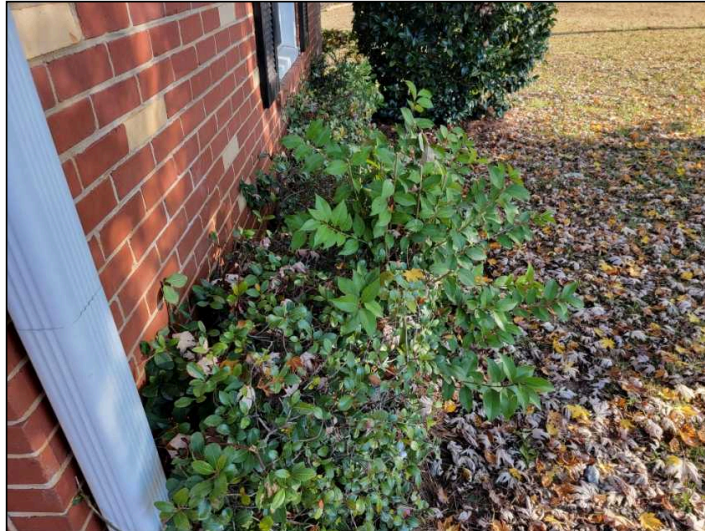
- Prune or remove any plants that are in contact or proximity to home to eliminate pathways of wood destroying insects.

Prune Vegetation

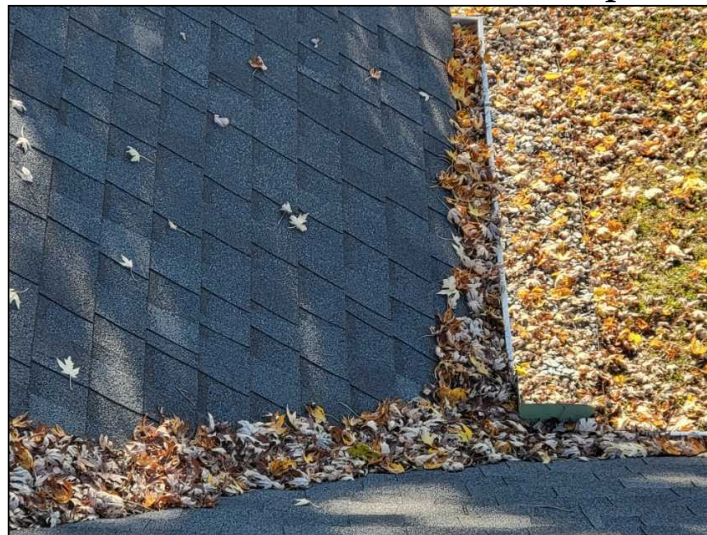
Full of Debris

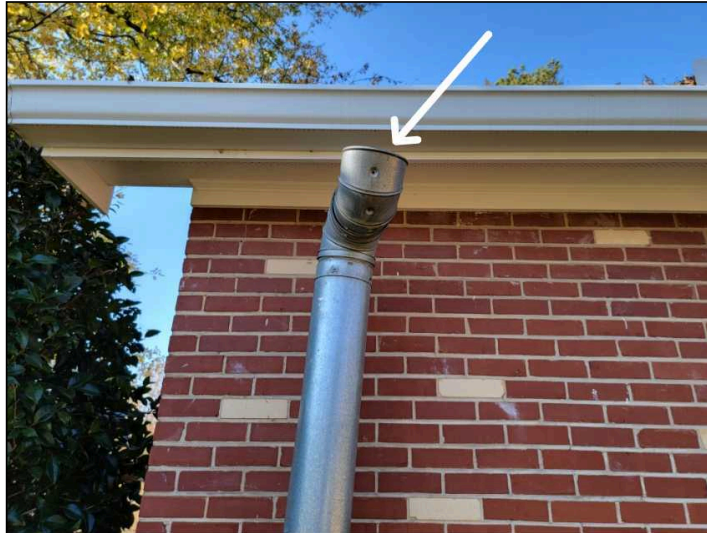
- Open vent pipe observed. Recommend installing proper rain cap by a qualified individual to help prevent water or vermin intruding into the home.

Open Vent/No Rain Cap

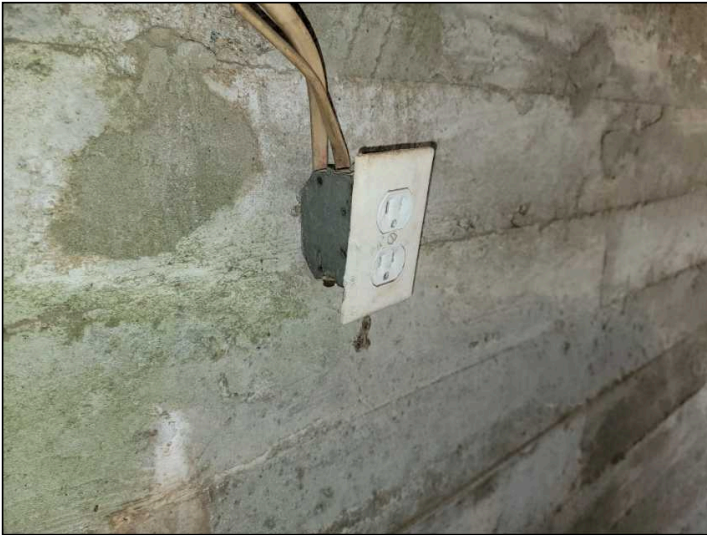
- Loose or improperly installed receptacles were found, they should be installed correctly by a licensed electrician or a qualified contractor.
- Open ground receptacle noted. This means that the 3rd (round) part of an appliance plug is not getting ground protection. This may be a concern with items such as computers and electronic devices.

Loose Receptacle

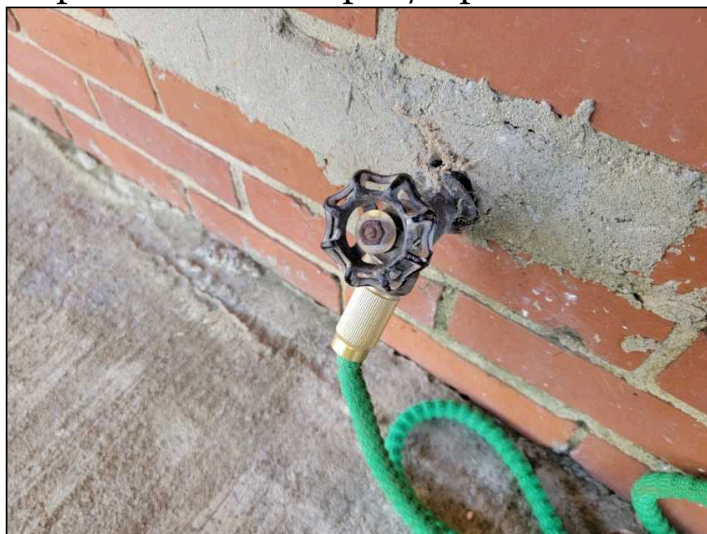
- Loose at structure, repairs needed to prevent possible damage to supply line. Recommend a qualified professional to repair/replace as needed.

Rear (Loose)

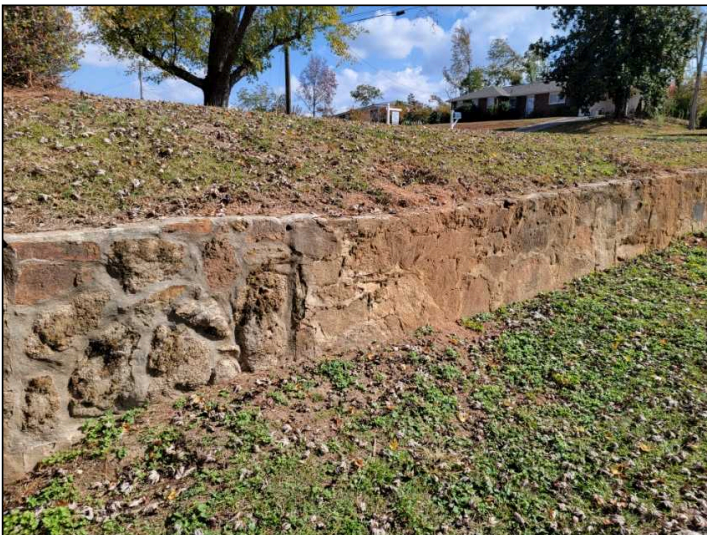
Page 20	Fence/ Gate Condition	<ul style="list-style-type: none"> <li>• <b>Retaining walls over 30" high require fall protection/fence to be installed.</b></li> </ul>

- Gate appears damaged, worn and or sags and not easy to close/latch. Recommend a qualified individual to make repairs for ease of operation.
- **Retaining walls over 30" high require fall protection/fence to be installed.**

No Fall Protection

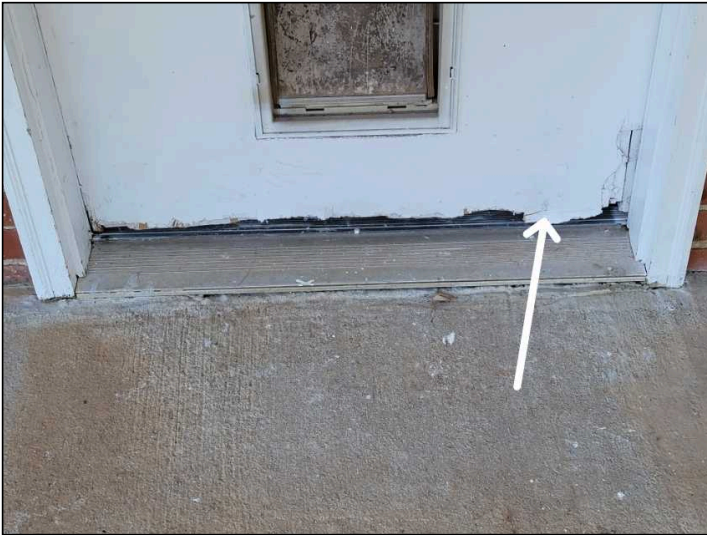
- Wood damage or deterioration observed. Suggest repairs/replacement as needed.
- Daylight visible through the crack/gap under the door. Recommend a qualified individual to evaluate and address as needed to help prevent rodent/insect intrusion and better energy efficiency.
- Door handle does not lock properly, adjustments are needed. Recommend a qualified individual evaluate and address as needed.

Damaged Wood

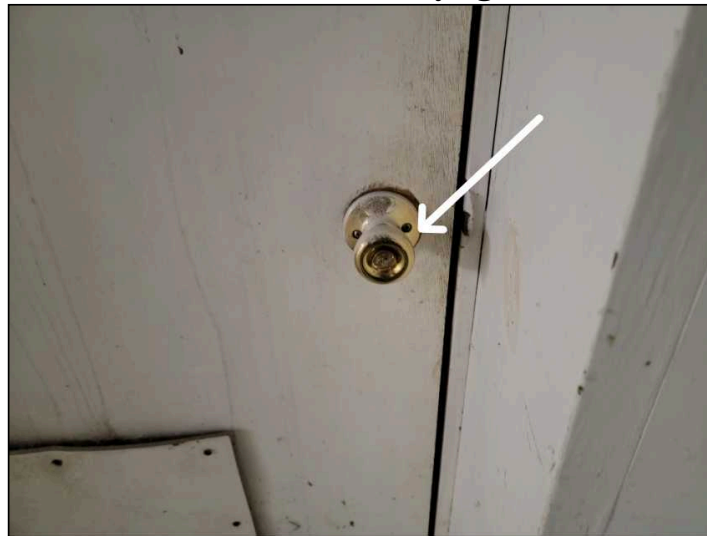
Door Handle Does Not Lock (Basement)

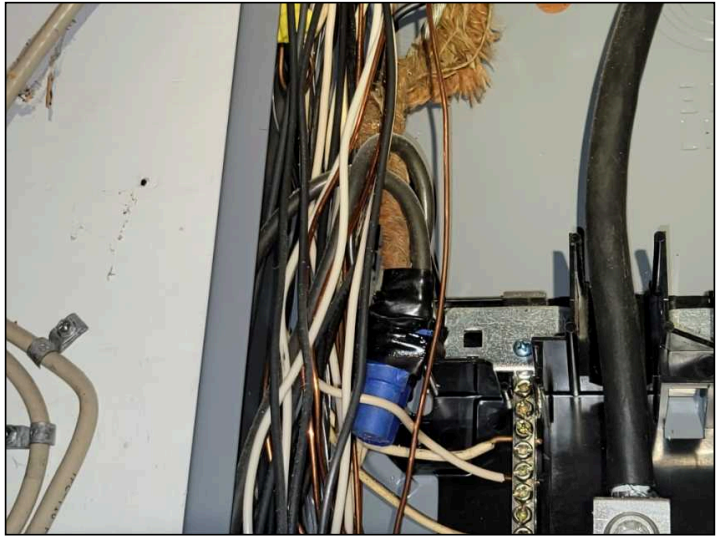
Page 23	Electrical Panel	<ul style="list-style-type: none"> <li>• <b>Questionable wiring in panel box. Appears to be ungrounded cloth wiring present. Have a licensed electrician evaluate.</b></li> <li>• <b>Sharp-pointed metal screws hold panel cover in place. These are a potential hazard as they may puncture wire insulation and electrify panel box, becoming a shock hazard. These screws should be replaced with approved, flat-tipped screws.</b></li> <li>• <b>Knockouts need snap-in caps inside panel box. Should be installed to keep mice out of panel box and to avoid potential electrocution hazard.</b></li> <li>• <b>Bushings missing from around branch wire(s) entering panel box. These should be installed by a Licensed Electrician to reduce the risk of shock or arcs.</b></li> </ul>
---------	------------------	--

- **Questionable wiring in panel box. Appears to be ungrounded cloth wiring present. Have a licensed electrician evaluate.**
- **Sharp-pointed metal screws hold panel cover in place. These are a potential hazard as they may puncture wire insulation and electrify panel box, becoming a shock hazard. These screws should be replaced with approved, flat-tipped screws.**
- **Knockouts need snap-in caps inside panel box. Should be installed to keep mice out of panel box and to avoid potential electrocution hazard.**
- **Bushings missing from around branch wire(s) entering panel box. These should be installed by a Licensed Electrician to reduce the risk of shock or arcs.**

Questionable Wiring (Main Panel)

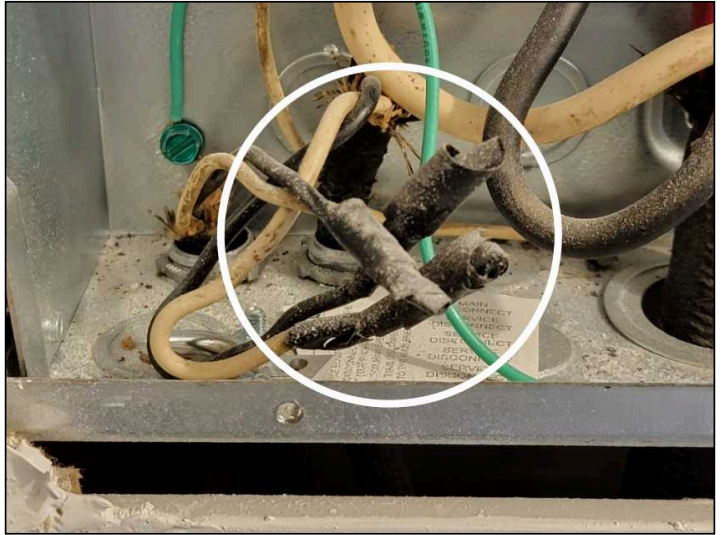
Questionable Wiring (1st Sub Panel)

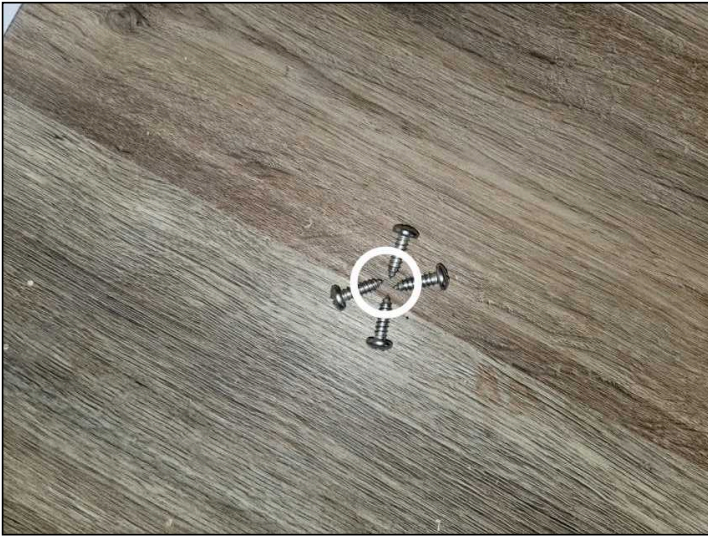
Sharp Pointed Screws (1st Sub Panel)

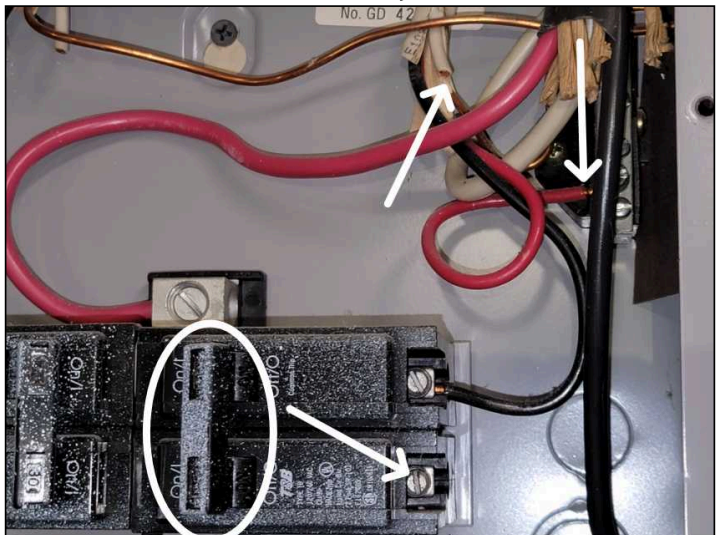
Questionable Wiring (2nd Sub Panel)

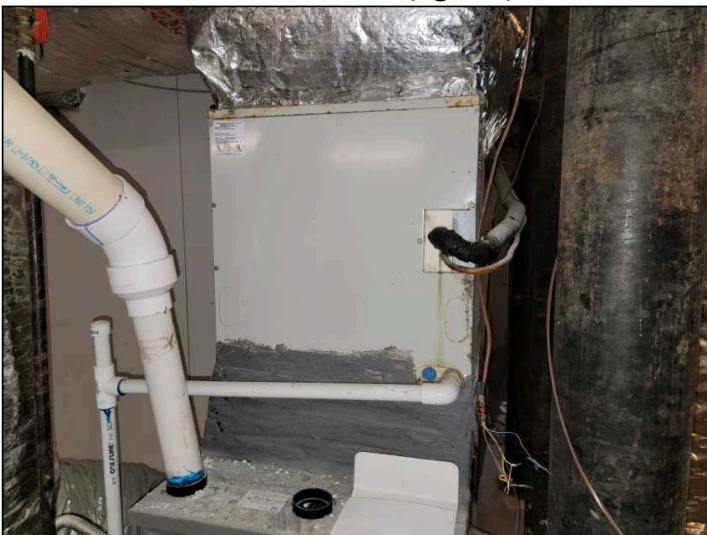
Page 27	Heater Condition	<ul style="list-style-type: none"> <li>• <b>Blower fan makes irregular noises. This could be an indication of a worn or damaged unit. Recommend a qualified HVAC contractor evaluate and repair or replace as needed.</b></li> </ul>
Page 28	Filters	<ul style="list-style-type: none"> <li>• <b>No filter observed at the time of inspection. Recommend contacting owner for the location and size.</b></li> <li>• <b>Filter cover is missing. Recommend installing to prevent dirt, dust or vermin intrusion and to help prolong the life of the unit.</b></li> </ul>

Fan Makes Irregular Noises

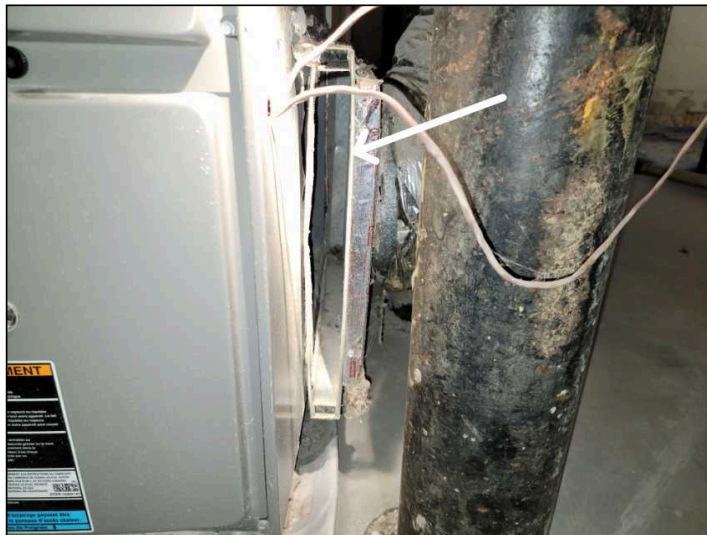
- **No filter observed at the time of inspection. Recommend contacting owner for the location and size.**
- **Filter cover is missing. Recommend installing to prevent dirt, dust or vermin intrusion and to help prolong the life of the unit.**

No Filter Installed & Missing Cover

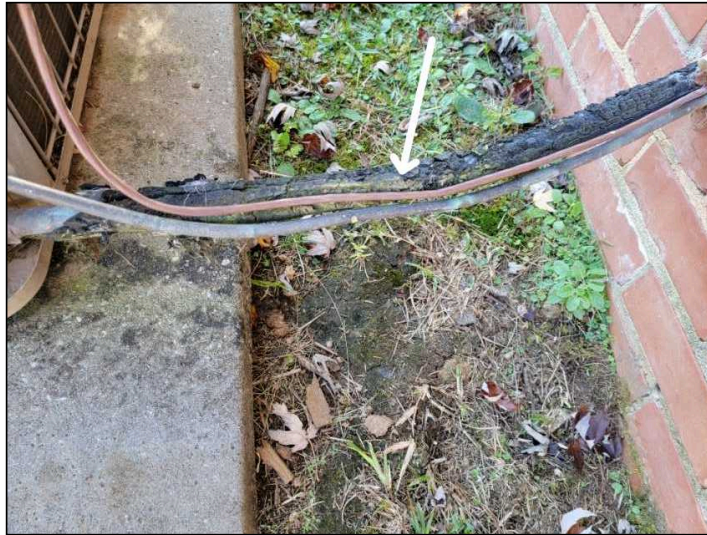
- Missing, damaged or deteriorated insulation noted at **A/C** unit. Recommend replacing.

Missing/Damaged Insulation

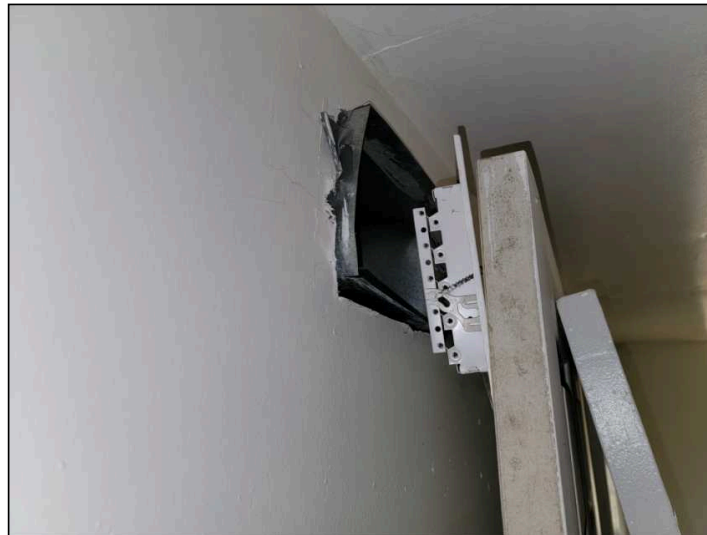
- Damaged/loose supply vents noted. Recommend repair or replace by a qualified individual.

Loose Supply Vent

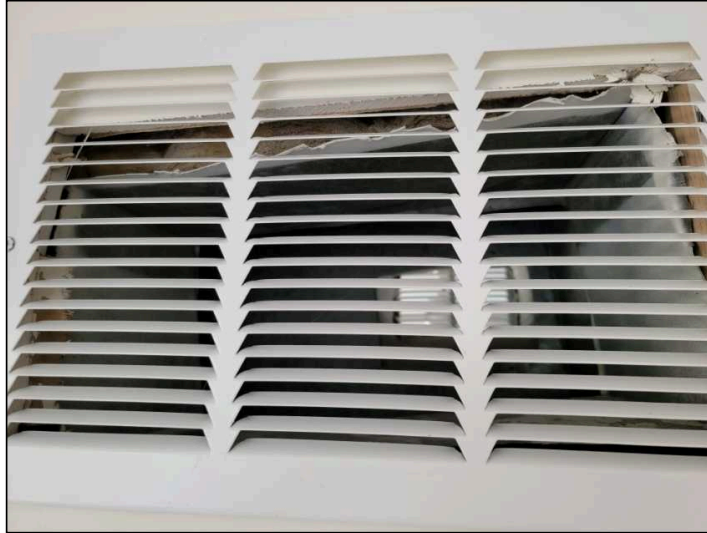
- Damaged ductwork noted. Recommend a qualified HVAC contractor to evaluate and address as needed to prevent rodent intrusion and better energy efficiency.

Duct Appears Damaged/Loose

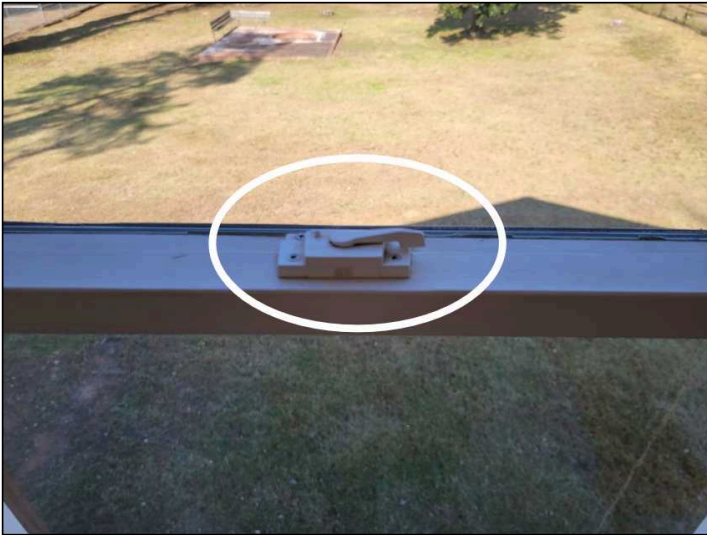
- One or more windows did not lock/latch properly, recommend repairs for enhanced security/safety to occupants.
- Some windows did not open when tested. Recommend all windows reviewed for proper operation during walkthrough inspection prior to closing.

Does Not Lock (Master Bathroom)

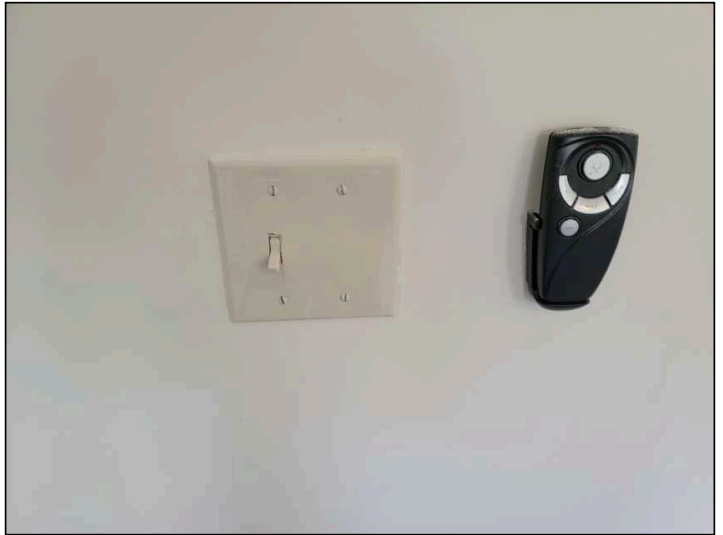
Switch Installed Upside Down (Left Bedroom)

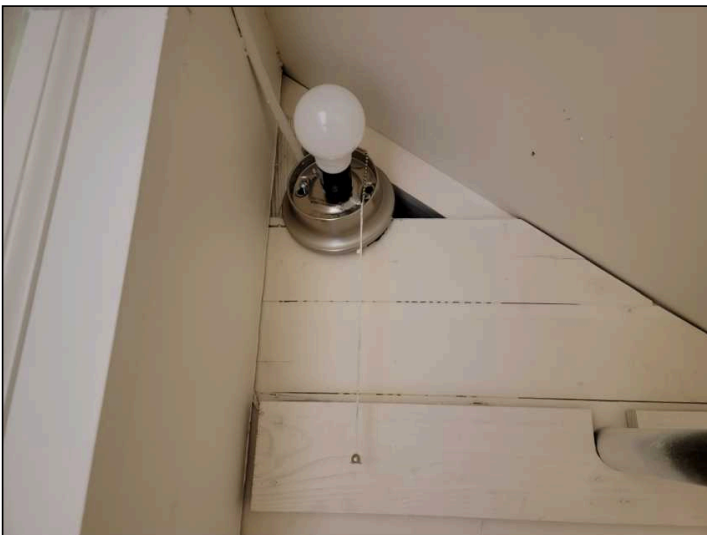
Light Installed Upside Down (Upstairs Hall Closet)

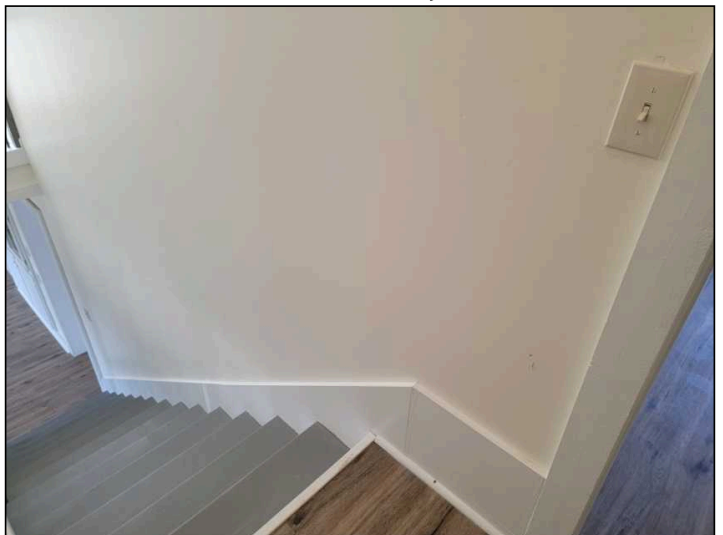
3 Way Switch Not Wired Properly (Stairway)

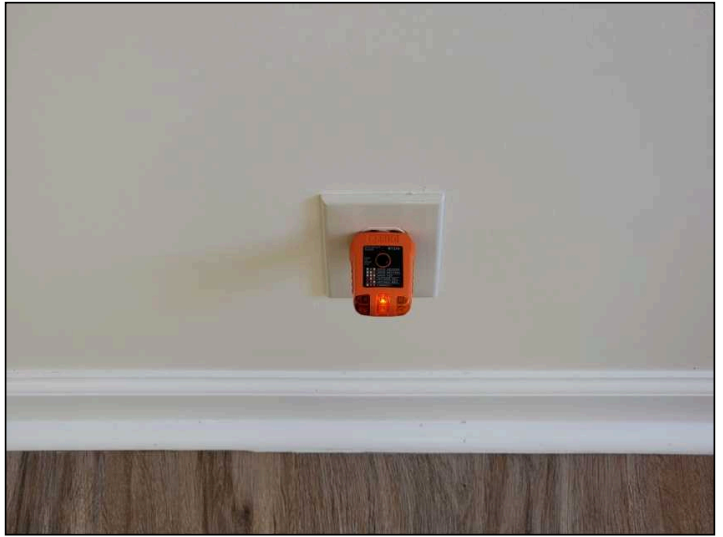
Open Ground (Main Level Front Bedroom)  
ALL Receptacles

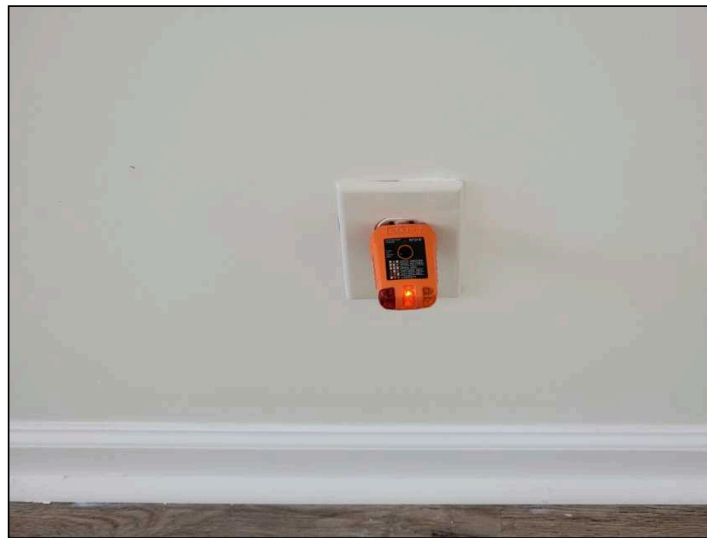
- Switches installed upside down. Recommend correcting for proper known functionality.
- Three way switch is not wired correctly. Does not function properly. Recommend repairs by a qualified individual.
- Loose fixture or covering observed. Recommend properly attaching or securing to prevent falling, damage or injury.
- Loose or improperly installed receptacles were found, they should be installed correctly by a licensed electrician or a qualified contractor.
- Light fixture installed upside down. Recommend correcting for proper ease of functionality.
- Open ground receptacle noted. This means that the 3rd (round) part of an appliance plug is not getting ground protection. This may be a concern with items such as computers and electronic devices.
- **Wire ends are outside of a Junction Box, which is a potential shock hazard.**

Open Ground (Master) ALL Receptacles

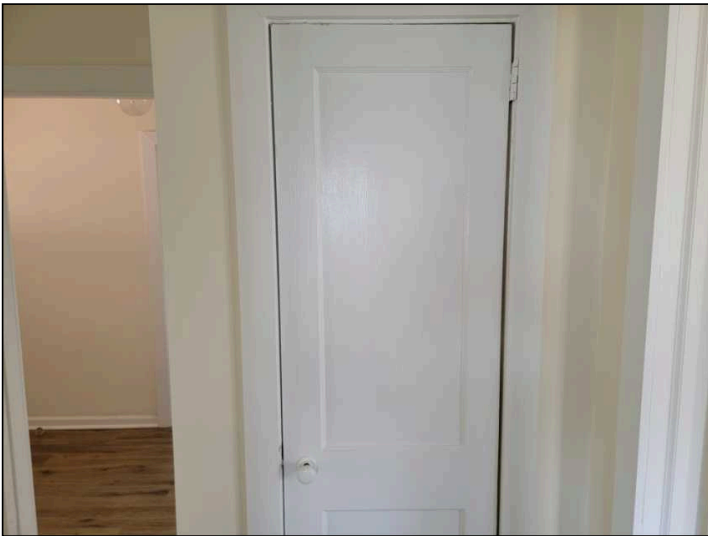
- Damaged, loose or missing hardware observed. Recommend repairing or replacing these components for proper functionality.
- Door does not close/latch properly. Adjustments needed for proper functionality.
- Door is a bit tight in jam, possibly from the new coat of paint or misalignment.

Tight in Jam (Master Bedroom Hallway)

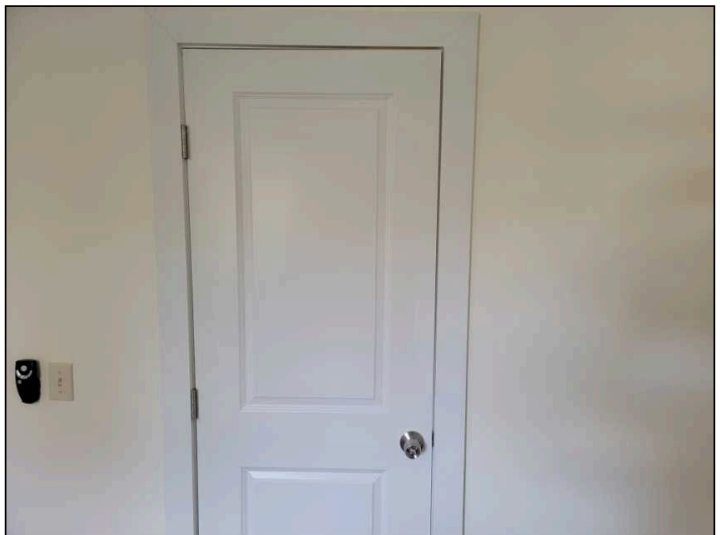
Does Not Close/Latch (Upstairs Right Bedroom)

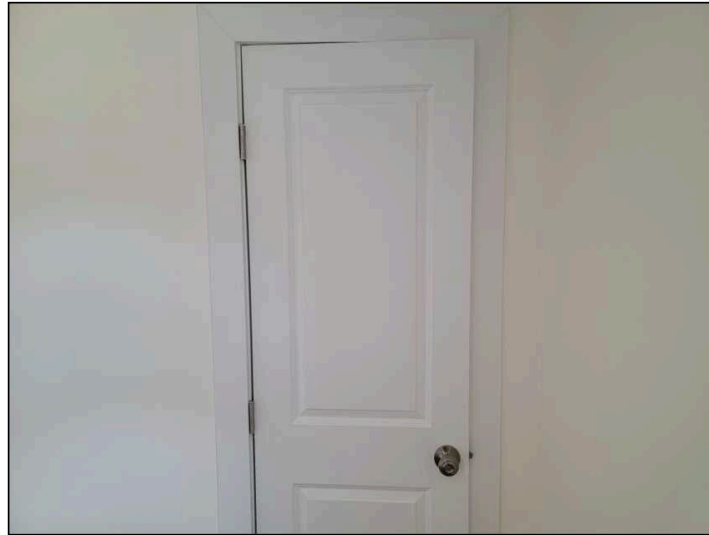
Does Not Close/Latch (Upstairs Right Bedroom Closet)

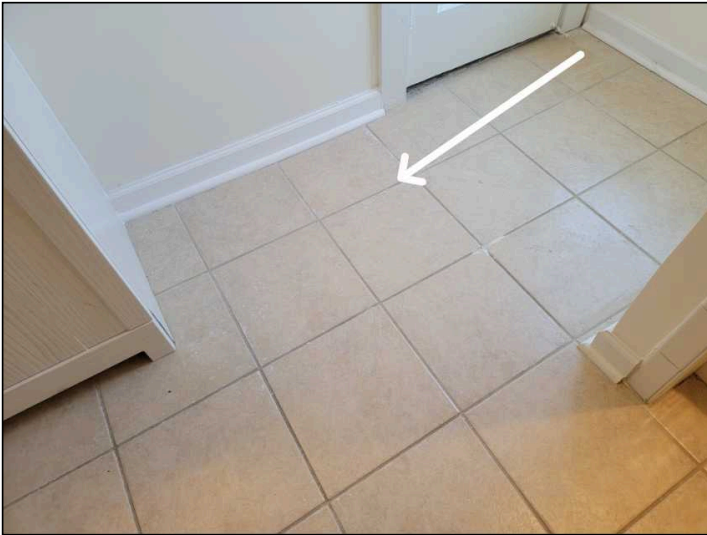
- Uneven flooring noted. This is common in older homes due to settling. If a more in depth review is desired, recommend consulting with a qualified contractor for further evaluation.
- Damaged/Loose flooring observed. Recommend repairs by a qualified contractor or individual.

Uneven Flooring

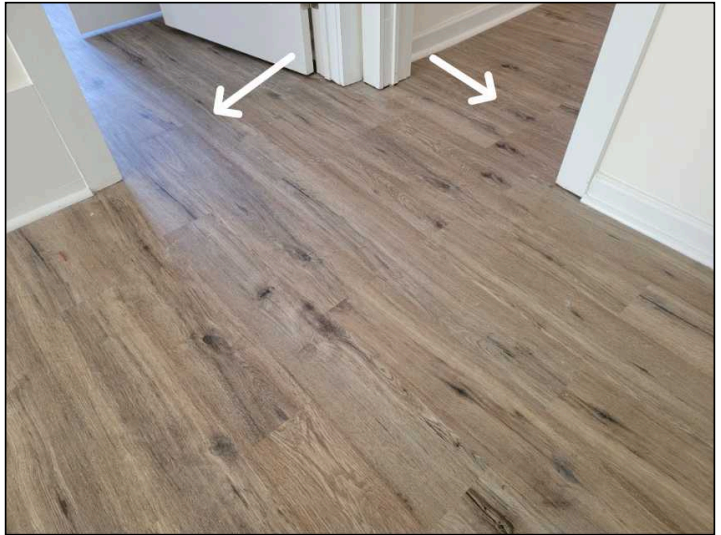
Uneven Flooring

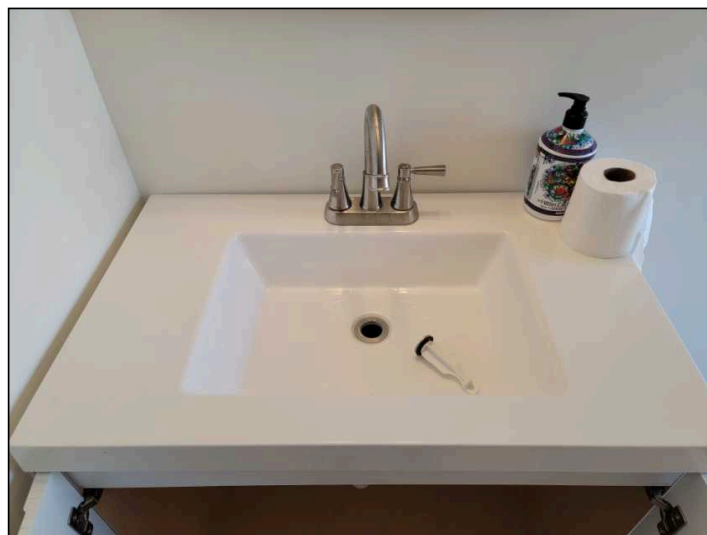
- **The counter top appears to be loose on the cabinet. Recommend a qualified contractor or individual properly re-fasten/secure the counter top.**

Loose Countertop (Upstairs Guest)

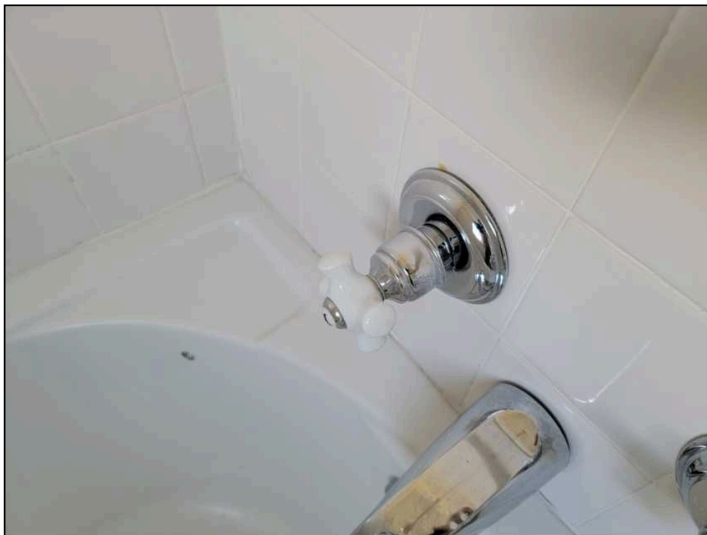
- Recommend caulking/sealing all crack, gaps and holes around the perimeter of the tub to keep water from infiltrating the walls or flooring.
- Stopper is missing/inoperable. Recommend repair or replace by a qualified individual.
- Whirlpool tub observed. Tub was filled to a level above the water jets and operated to check intake and jets. The tub was then drained to check for leaks and/or damage. Pump and supply lines were not completely visible or accessible. GFCI's were present and was tested. The items tested appeared to be in serviceable condition. If a more detailed report is desired, the client is advised to consult a licensed plumber for a complete review prior to closing.
- **No hot water supply present at the tub, could not test. Recommend a qualified contractor or individual evaluate and address as needed.**

No Hot Water Supply (Guest)

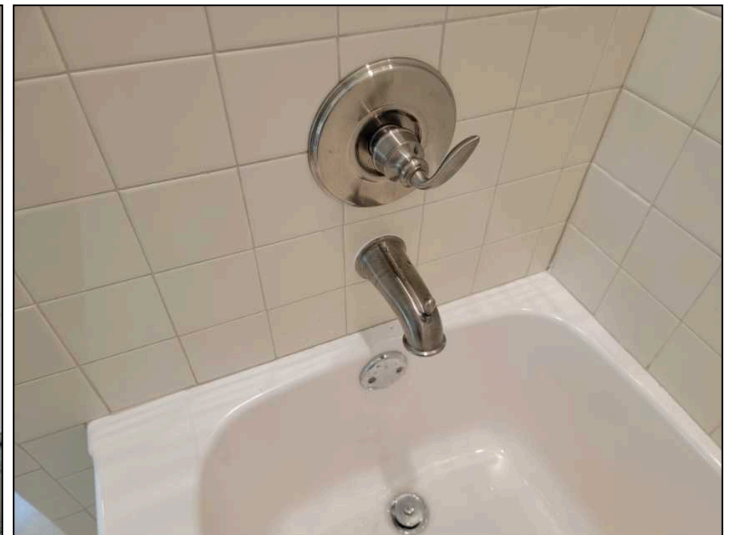
No Hot Water Supply (Upstairs Guest)

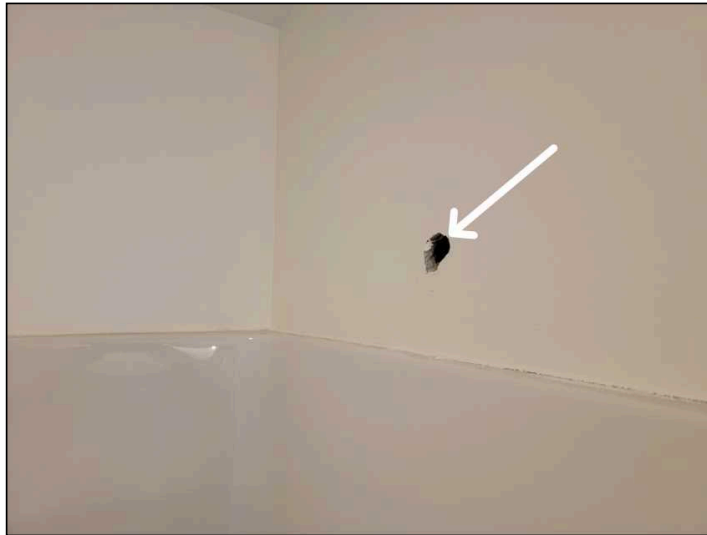
- **No plumbing nor shower head installed. Recommend a qualified contractor or individual to properly install a shower head.**

No Shower Head Plumbing

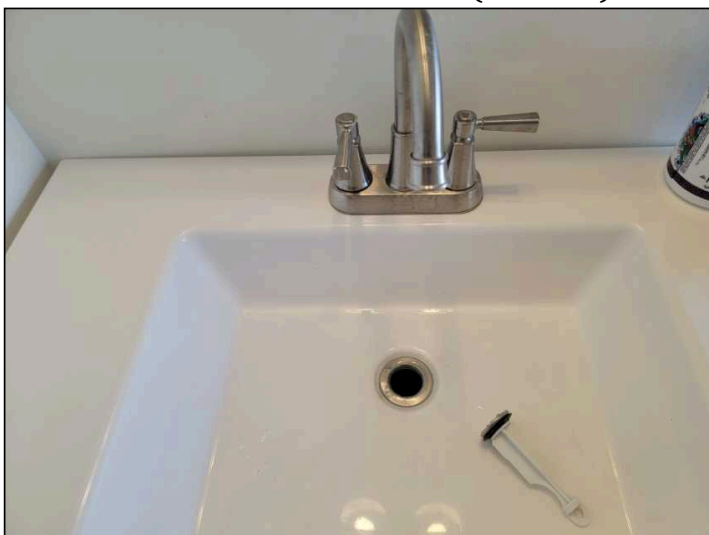
- No hot water supply present at the sink, could not test. Recommend a qualified contractor or individual evaluate and address as needed.
- Stopper is missing or inoperable. Recommend repair or replace for proper functionality.
- Faucet assembly is loose, suggest securing as necessary.
- Unprofessional repairs observed. Recommend a qualified contractor or individual make proper repairs to ensure no leaks occur.
- **Drain line leaks under sink. Recommend a qualified contractor to evaluate and address as needed.**

No Hot Water Supply & Stopper  
Inoperable (Upstairs Guest)

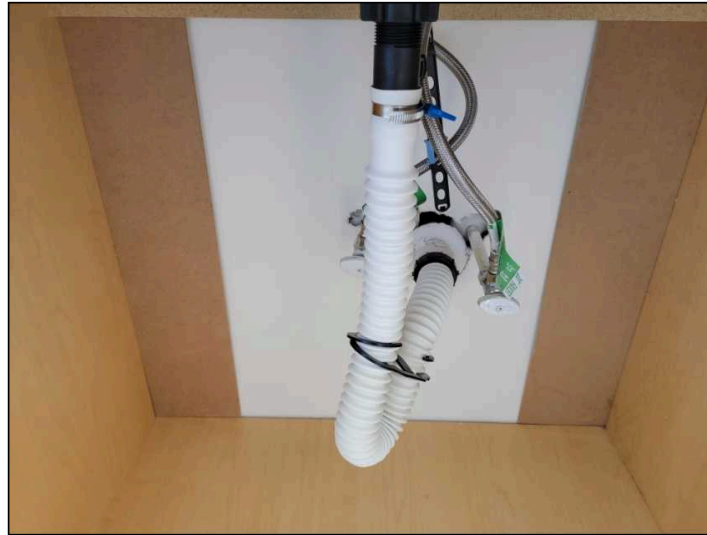
Unprofessional Repairs (Upstairs Guest)

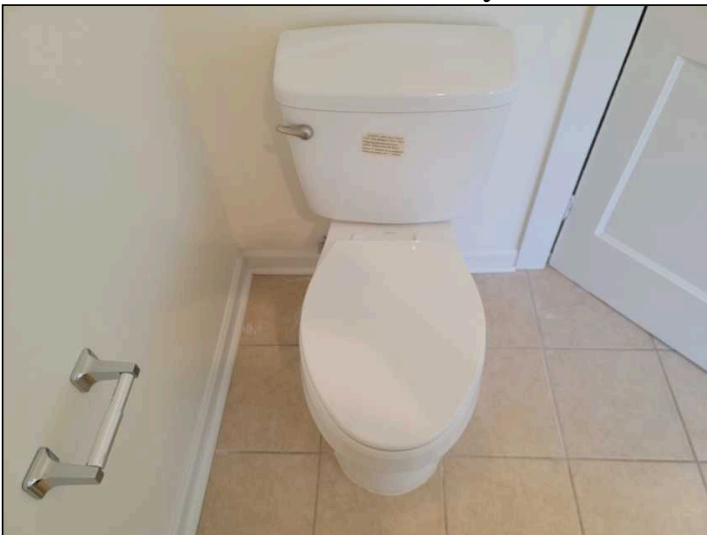
- Toilet loose at the base. May need re-anchoring.

Loose Toilet (Upstairs Guest)

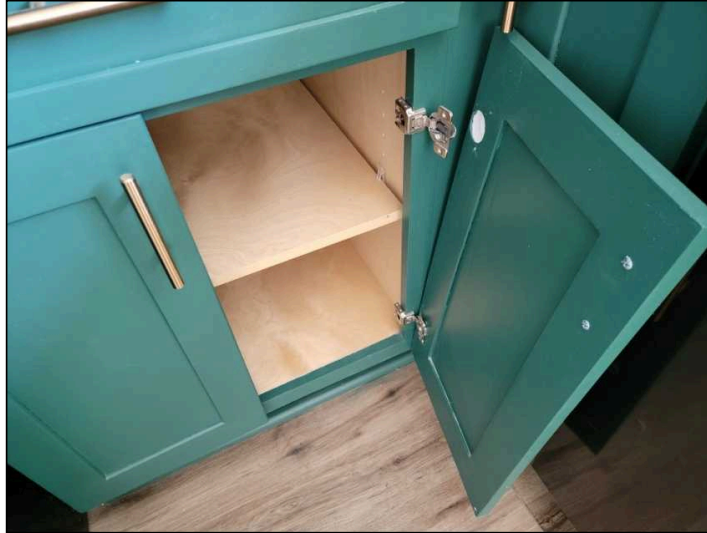
- Damaged, loose or missing hardware observed. Recommend repair/replacing these components for proper functionality.

Missing Screws (Both Hinges)

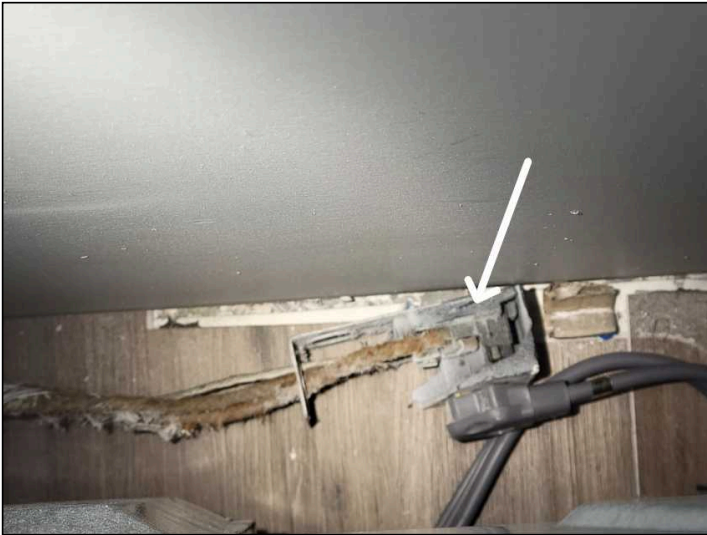
- Open ground receptacle noted. This means that the 3rd (round) part of an appliance plug is not getting ground protection. This may be a concern with items such as computers and electronic devices.
- **Electrical Box Covers missing or damaged, which is a potential shock or electrocution hazard.**

Range Plug Not Mounted/Missing Cover

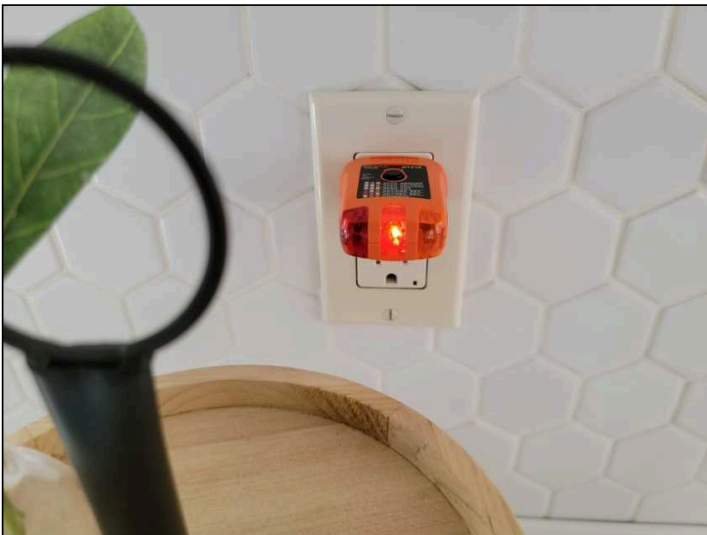
Open Ground

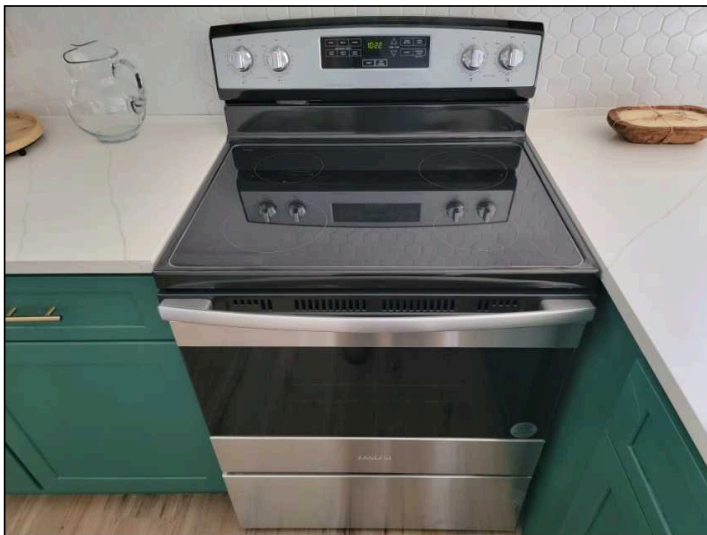
- Oven door contacts the cabinetry when open. Range has to be shifted in order to open the door.
- All heating elements operated when tested.
- Oven(s) operated when tested.
- Amana
- **Anti-tip bracket is missing from range installation. See label inside oven door. All free-standing, slide-in ranges include an anti-tip device and is essential in the safe operation of the range. It provides protection when excess force or weight is applied to an open oven door. Carried by home building centers.**

No Anti-Tip Bracket

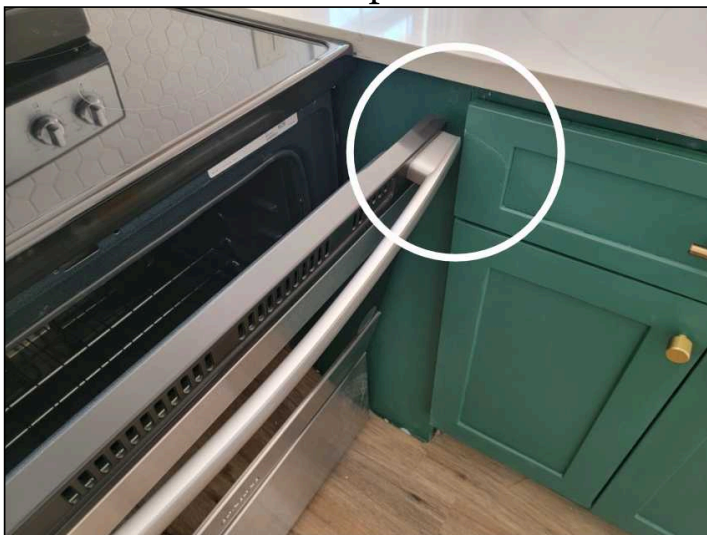
Door Contacts Cabinetry

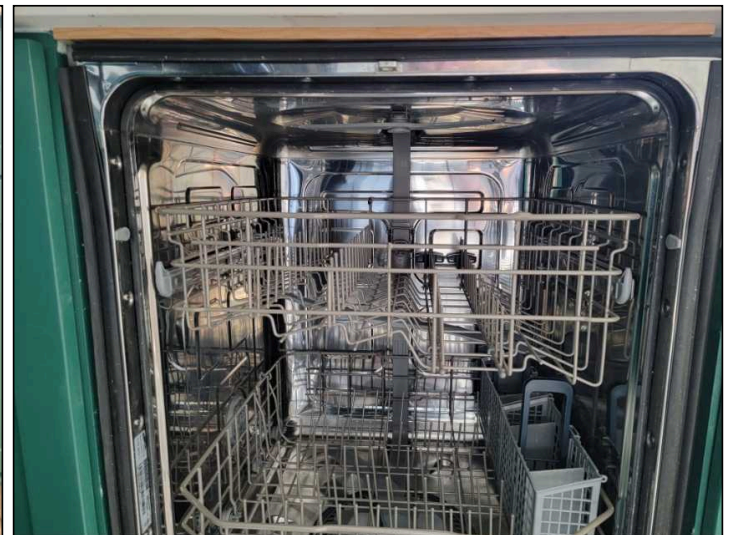
- Ran a complete cycle and operated normally at the time of inspection.
- Unit is not properly attached/fastened to the cabinetry or countertop. Recommend properly securing to prevent tipping forward and hold the unit level for optimal operation.

Not Mounted Properly

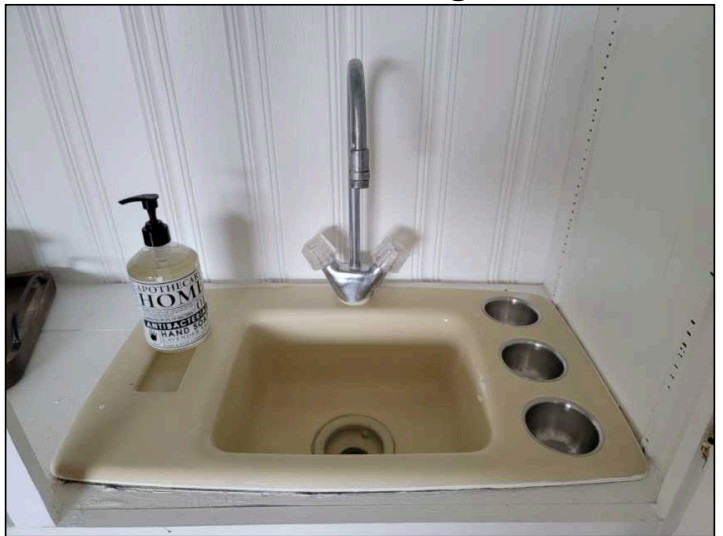
- Damaged, loose or missing hardware observed. Recommend repair/ replacing these components for proper functionality.
- Faucet inoperable at the time of inspection. Recommend further review by a qualified contractor or individual for repairs.
- No P-Trap visible. P-Traps are required to be installed anywhere there is an open drain line. The P-Trap should be located No more than 24" below the drain. Recommend a qualified individual to further evaluate to verify there is a P-Trap or install a P-Trap.
- Unprofessional repairs observed. Recommend further evaluation by a qualified contractor or individual to make proper repairs to ensure there are no leaks.
- **Drain line leaks under sink. Recommend a qualified contractor or individual evaluate and address as needed.**

Sink Inoperable

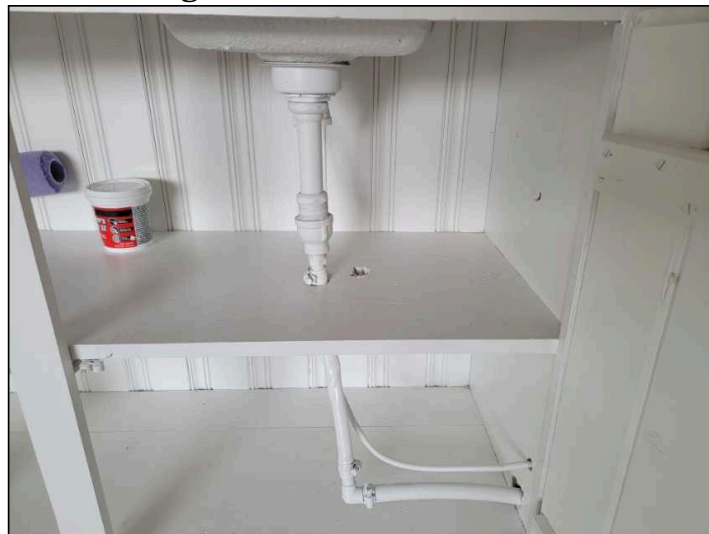
No P-Trap

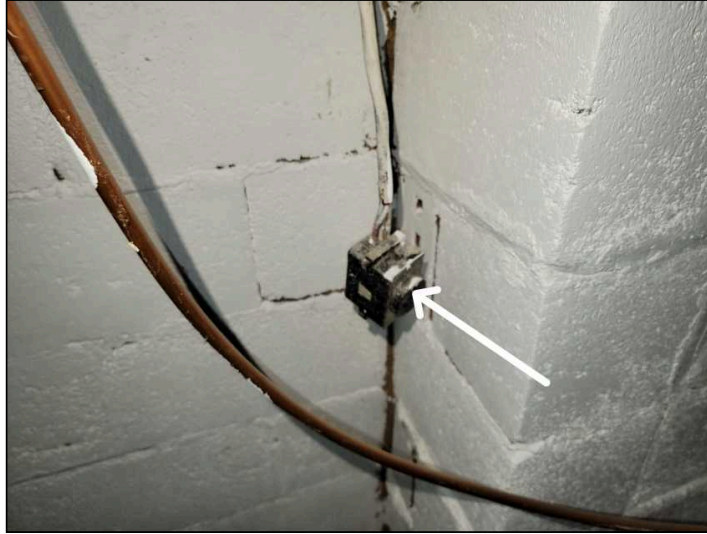
- Loose or improperly installed dryer receptacle found, it should be installed correctly by a licensed electrician or a qualified contractor. Recommend repairs as needed.

Loose Dryer Receptacle

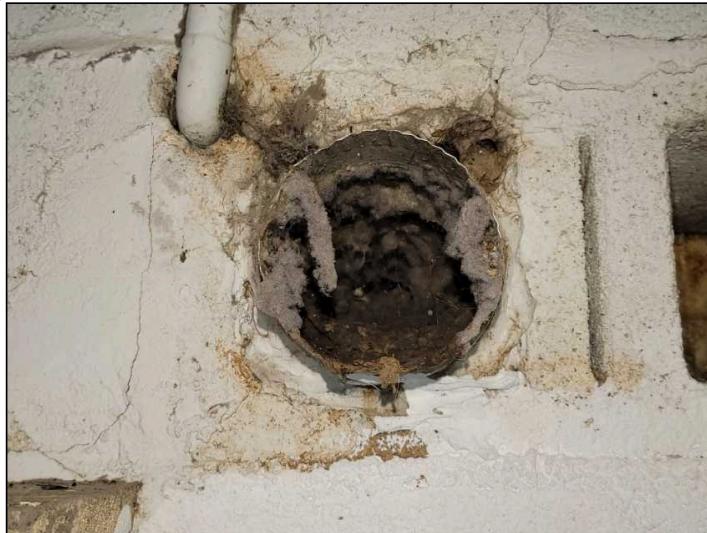
- Vent is dirty and appears clogged. Recommend cleaning to allow the flapper to open/close freely to prevent vermin intrusion.

Dirty Vent

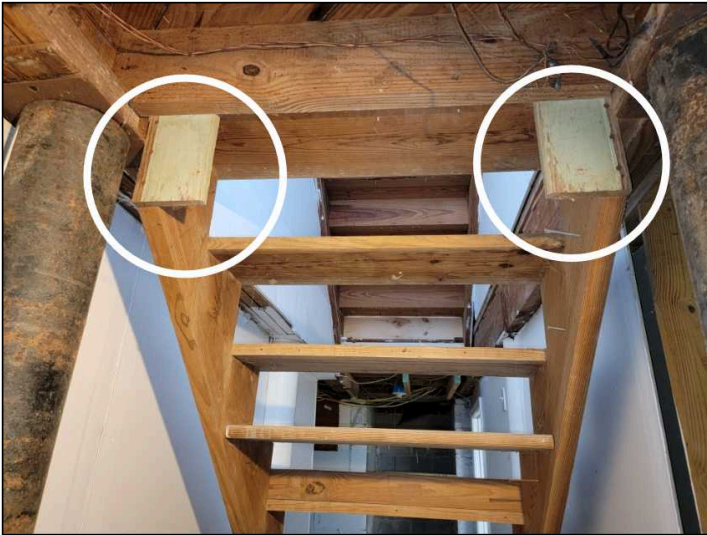
- **Steps are not properly connected or attached to the landing. Steps physically shake when walking up or down. Recommend a qualified contractor or individual properly attach steps and add support posts for added stability for safety sake.**
- **Steps that are 36" and wider require an additional stringer for added support and stability for safety. Recommend a qualified contractor or individual evaluate and address as needed.**

Not Properly Attached/No Supports

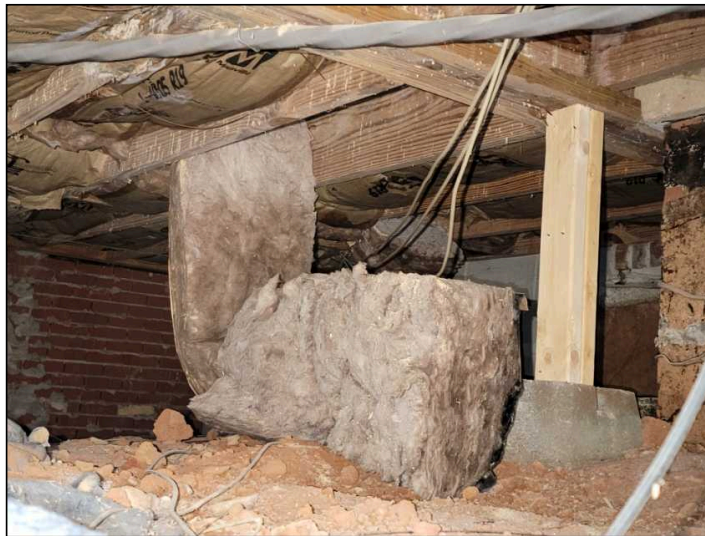
- Insulation was observed to be missing or out of place in the crawlspace. Recommend upgrading to promote proper insulation and increase the efficiency of home.

Loose Insulation

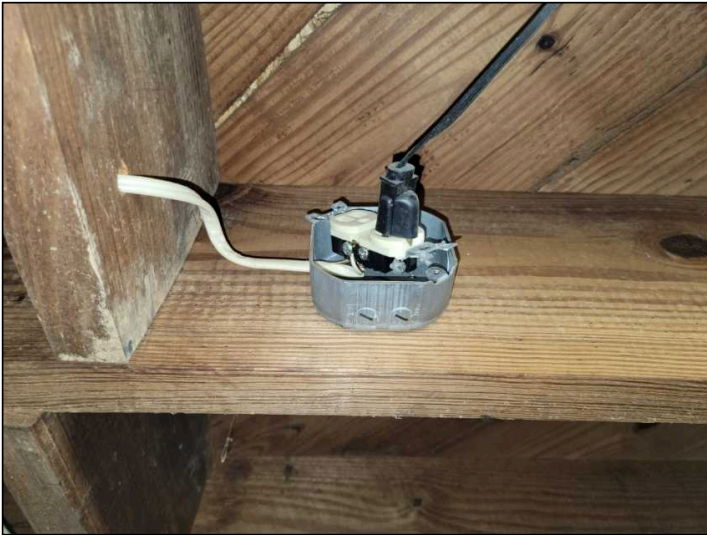
- Loose or improperly installed receptacles were found, they should be installed correctly by a licensed electrician or a qualified contractor.
- Open ground receptacle noted. This means that the 3rd (round) part of an appliance plug is not getting ground protection. This may be a concern with items such as computers and electronic devices.
- Light fixture, switch or bulb apparently inoperable. Change bulb(s) and check.
- Two prong receptacles noted, this means they are not grounded and could put electronics at risk. Recommend upgrading to 3 prong/grounded receptacles. Repairs should be made by a professional, licensed or insured individual.
- Missing cover plates observed, suggest installing for safety.
- Open junction boxes were observed, which is a safety concern. Recommend installing proper covers, as needed, for safety.

Loose Receptacle

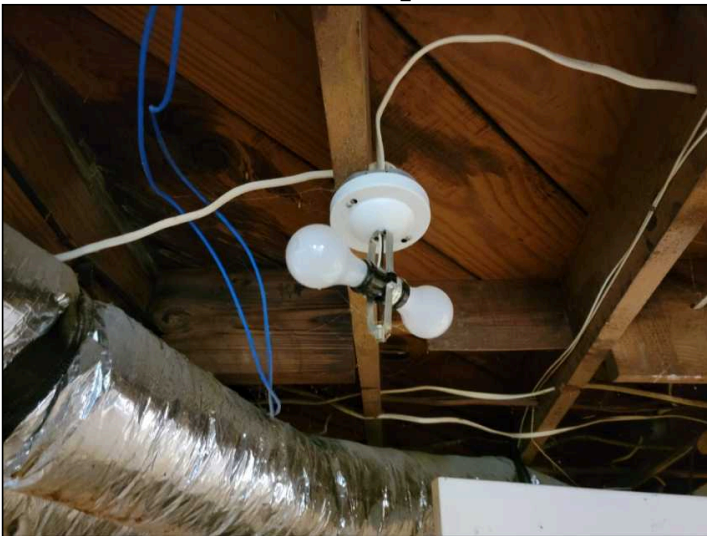
Light Inoperable
