# Thorough Inspections, Inc.

## Sample Report

1234 1st St, City/State/Zip

**Property  
Inspection  
Report**

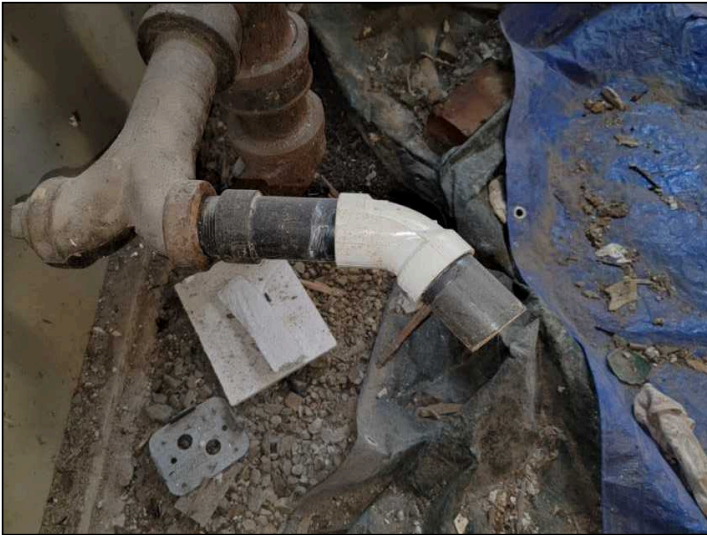
• Improper combination of dissimilar plastic drain pipe observed. There is no way to confirm that the use of a special PVC to ABS cement was used, most local building officials prohibit the combination of different types of plastic piping. Review and repair is recommended by a Qualified Plumber.

Unprofessional Repairs/Improper Connections

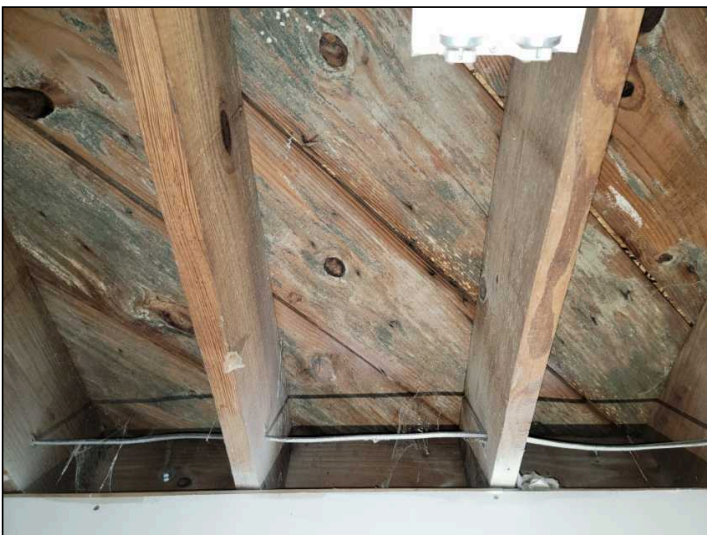
- **Bio Growth noted. Recommend consulting with a specialist to evaluate for treatment.**

Bio-Growth Observed
